Architect's Field Report

5465 Interstate 55 North Frontage Rd, Jackson, MS 39206

06 September 2022 Date of Site Visit

Mid-State Construction Contracting Company

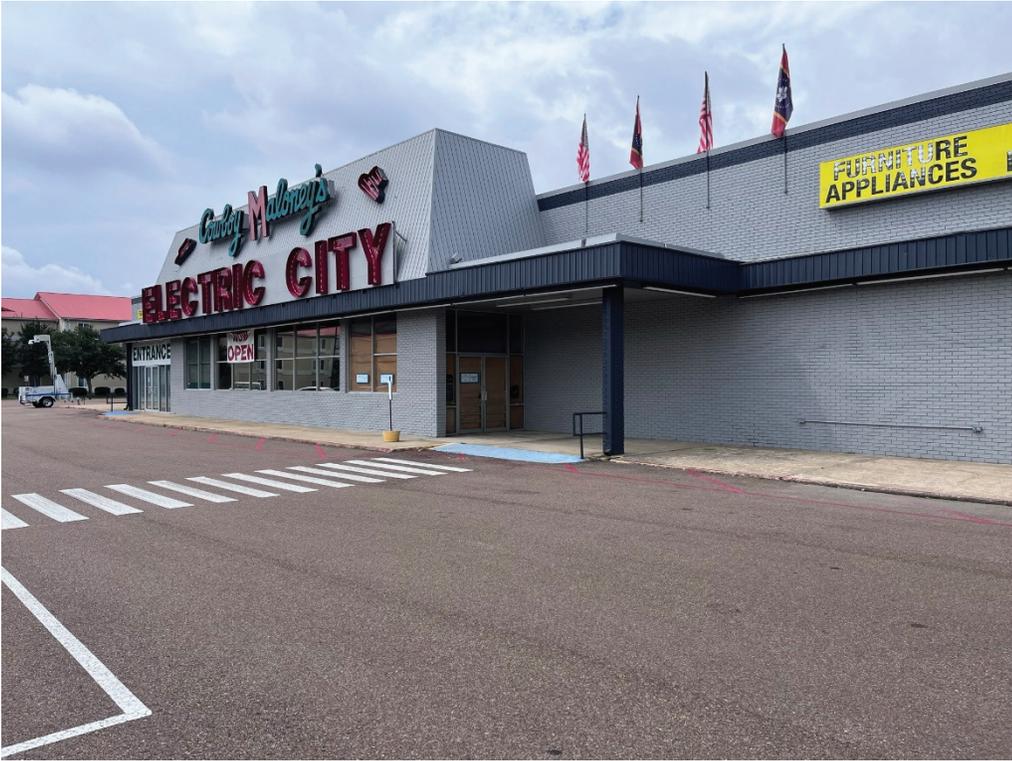
Figure 1 – Doors Locked Today

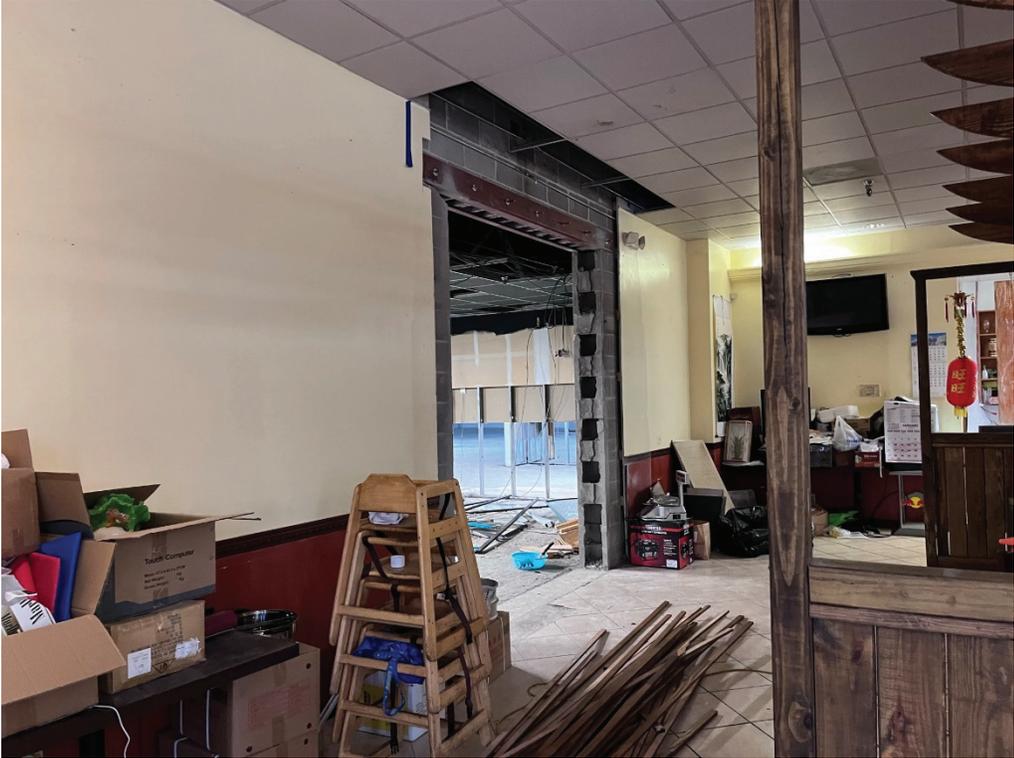
I mentioned to Mr. Lin that he was going to have a very high electricity bill because no separation between the renovated and existing spaces has been provided by the contractor. There should at minimum be a 6-millimeter plastic sheet installed and tape to walls and floor at the new openings.

Figure 3 – Air Transmittance between Conditioned and Unconditioned Space

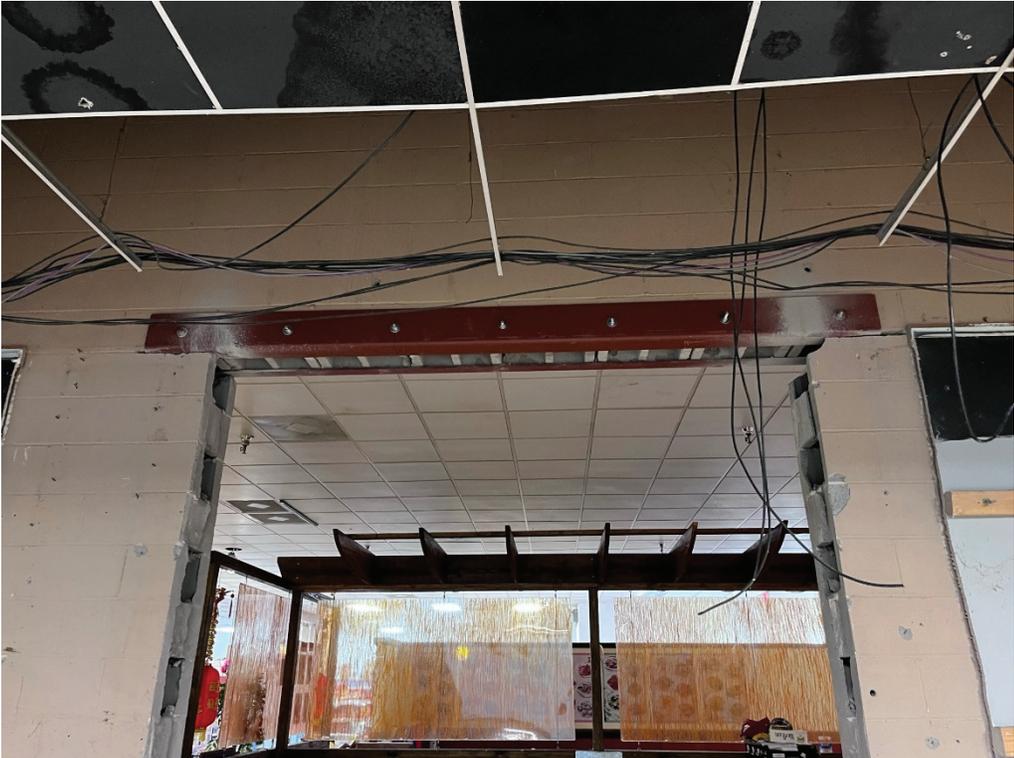
Concerning the openings, I have not been provided structural drawings, but I would think some kind of structural jamb should be provided to the floor and/or infill of Hollow block at the new openings. Has an engineer been by to see the installation? I will defer to whomever is over that part of the design as to what is the structural integrity of Cut CMU block.

Figure 4 – East Opening (advise on repair of CMU)

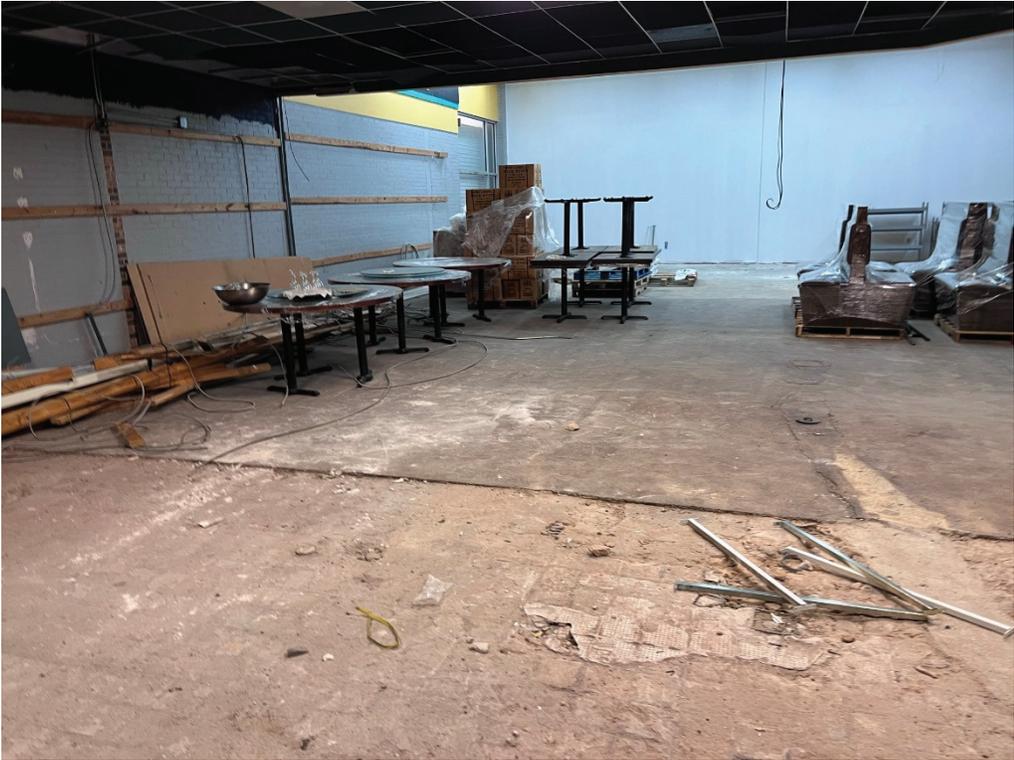
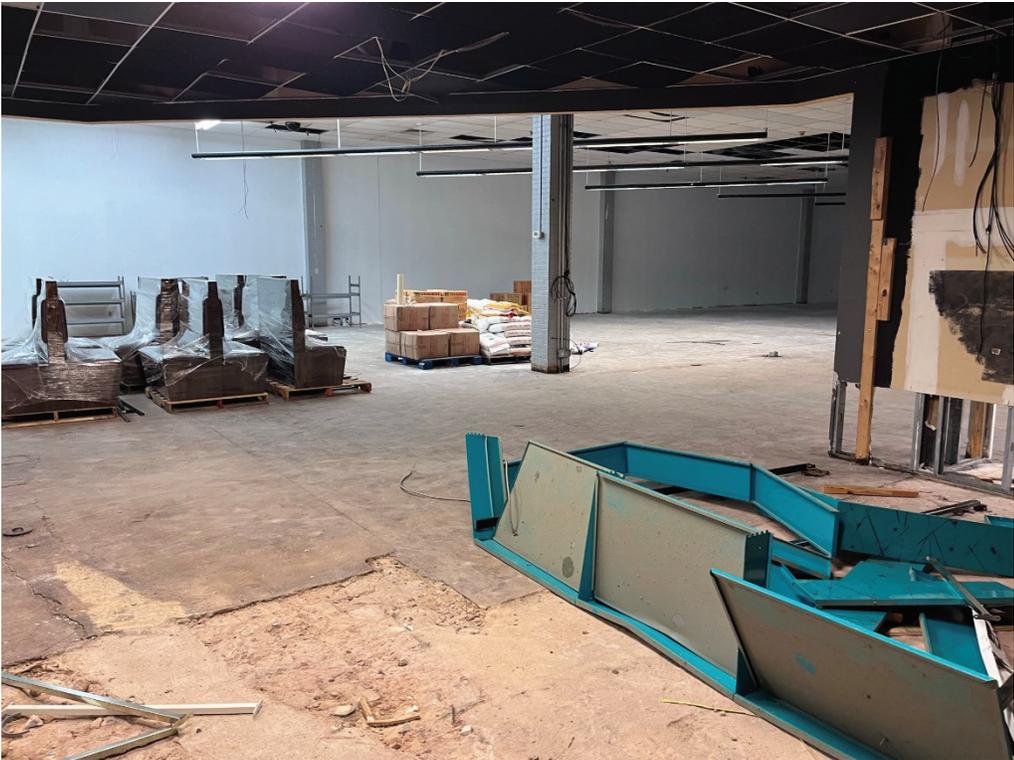
Figure 6 – South Space Used to for Storage

Figure 7 – South Space Used to for Storage

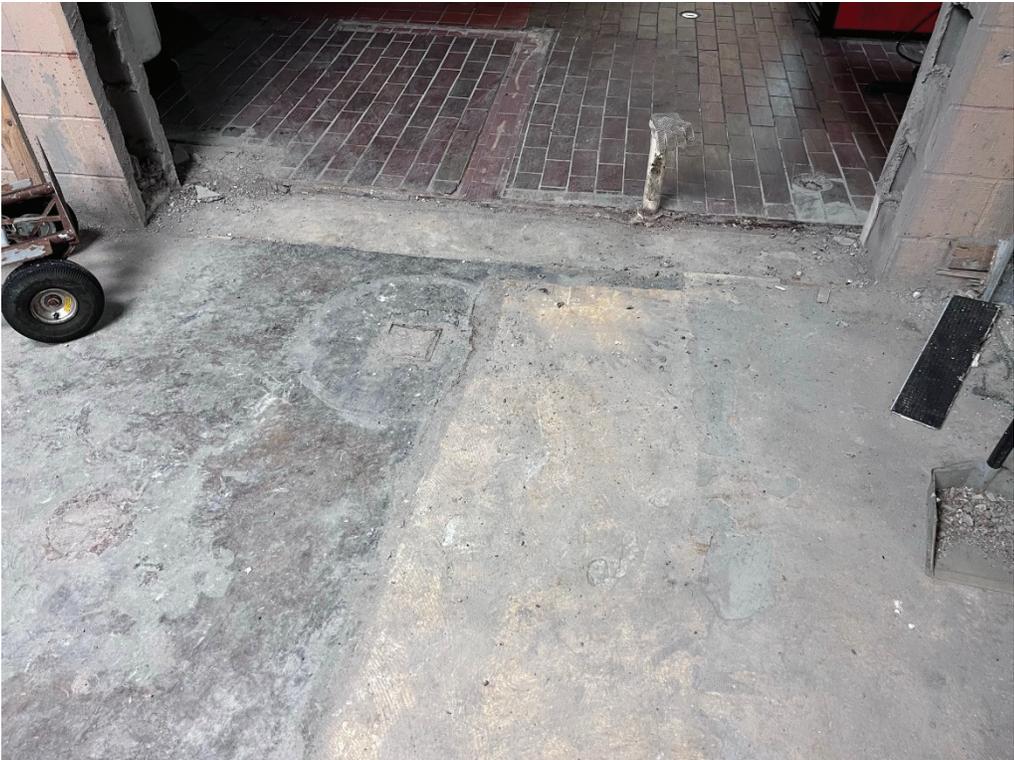
Figure 9 – Pipe at Middle Opening should be capped below slab

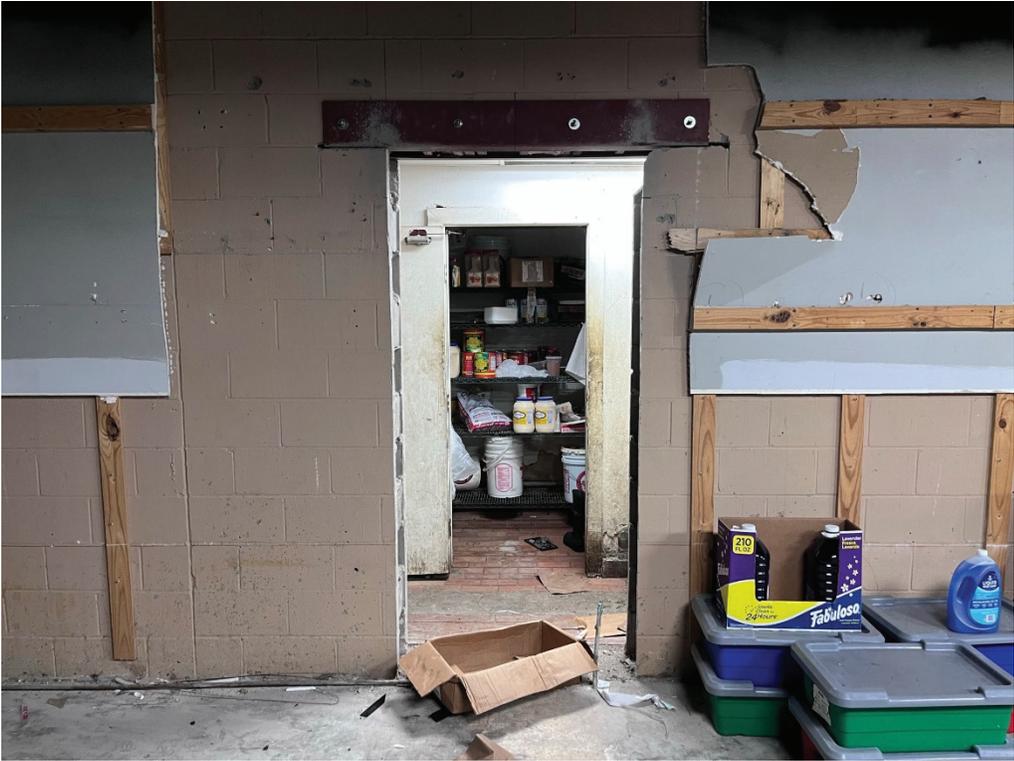
Figure 12 – Tenant Stored Items

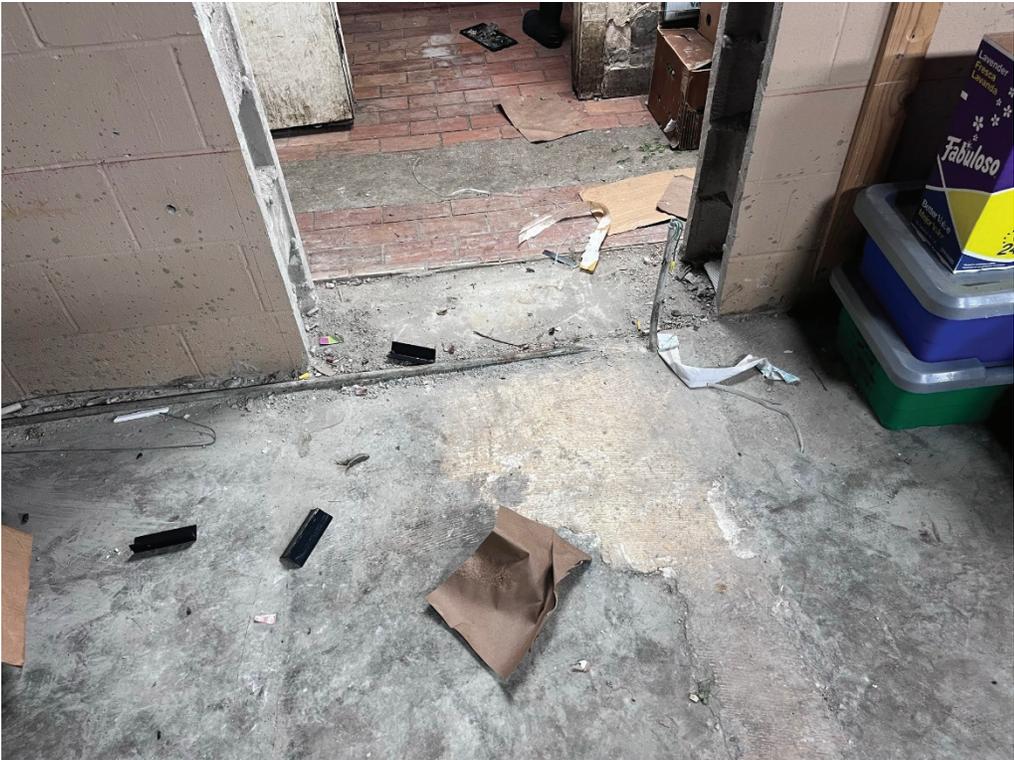
Figure 13 – Conduit at Opening (left run is coax cable)

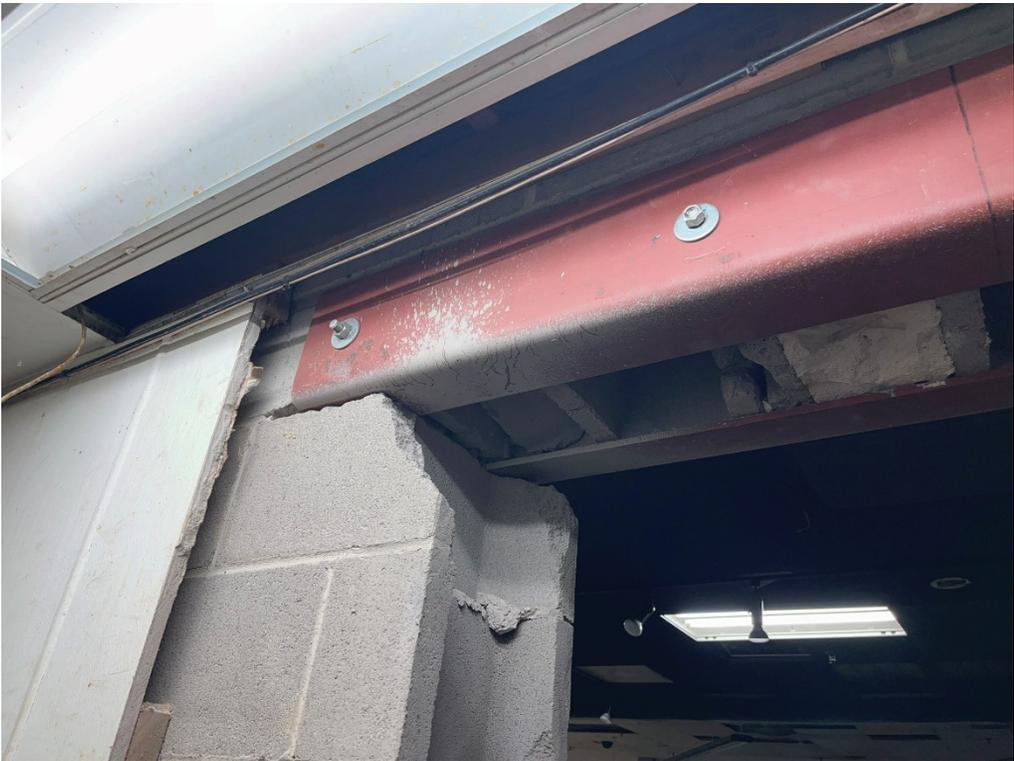
Figure 14 – Damaged CMU Block at Small Opening (advise on repair)
