Wednesday, November 2, 2022

Architect's Field Report

5465 Interstate 55 North Frontage Rd, Jackson, MS 39206

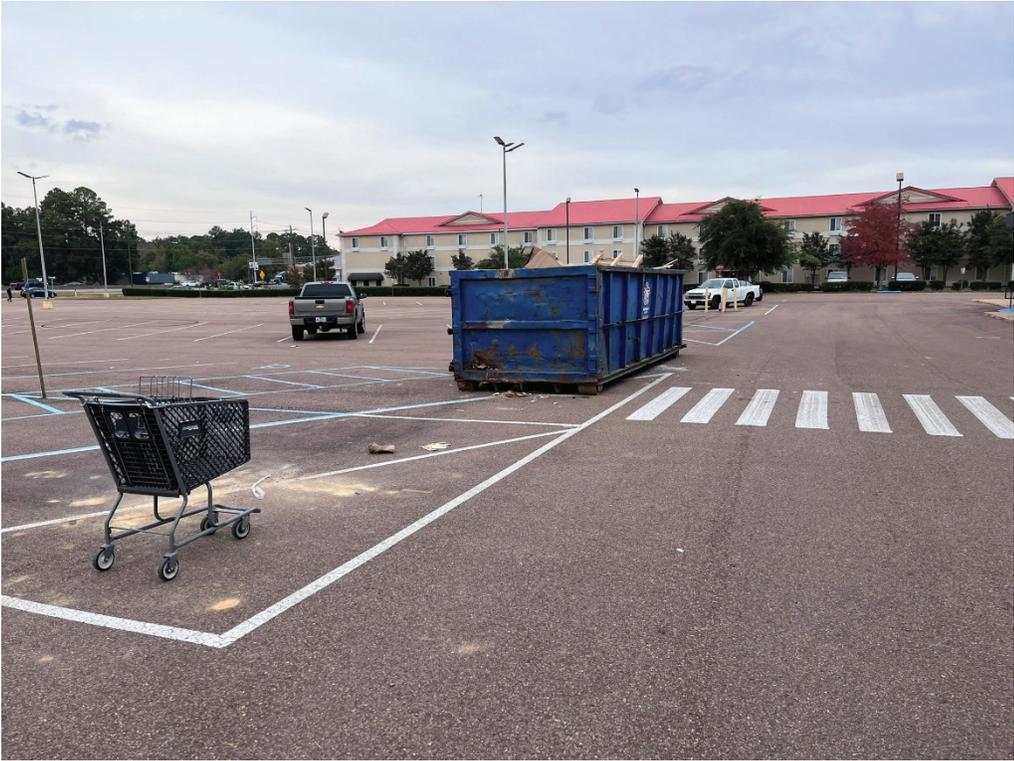
Figure 1 – Property Front; Some parking lot cleanup required by contractor

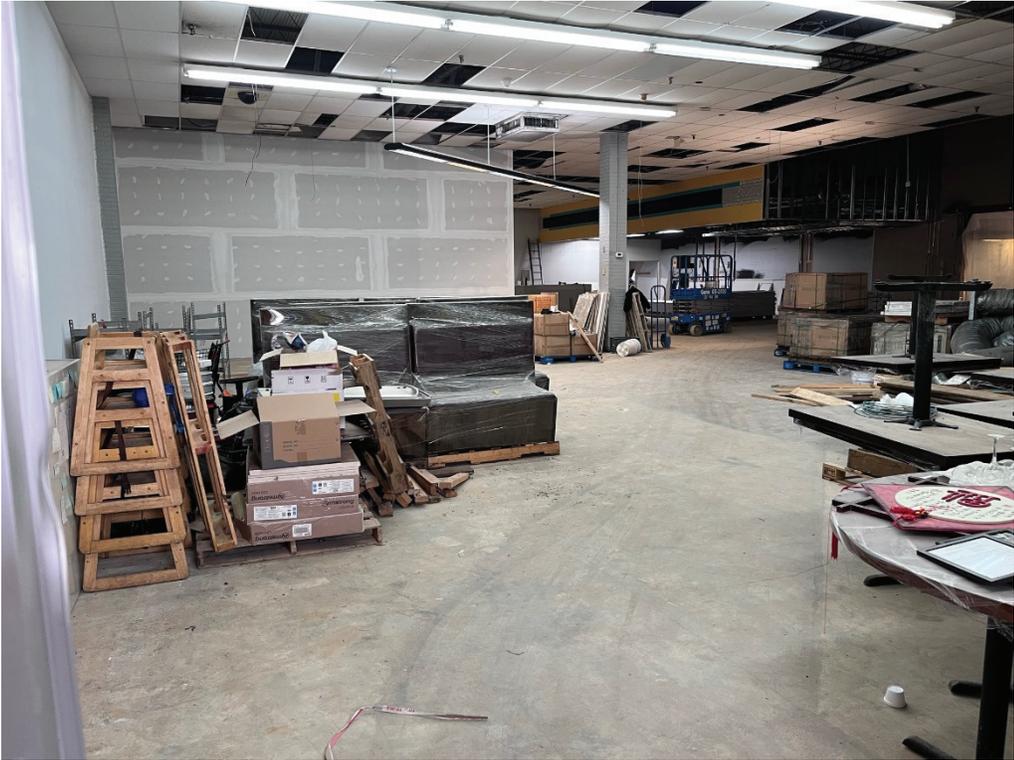
Figure 2 – Interior Mudwork has begun

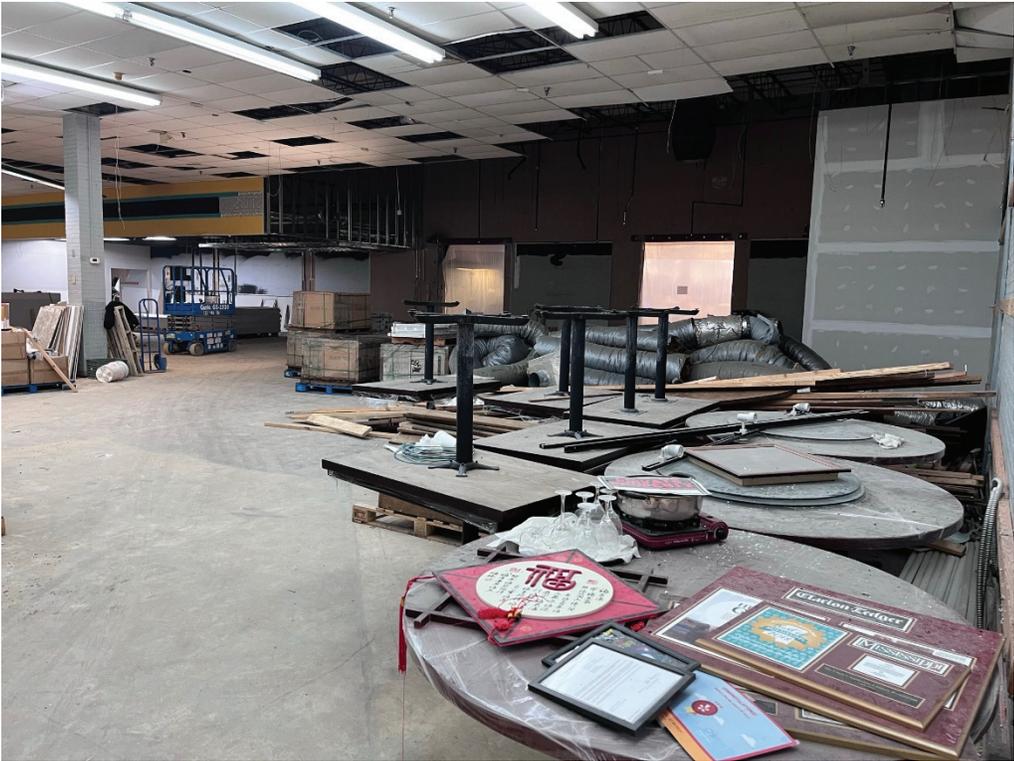
Figure 3 – Interior Mudwork has begun

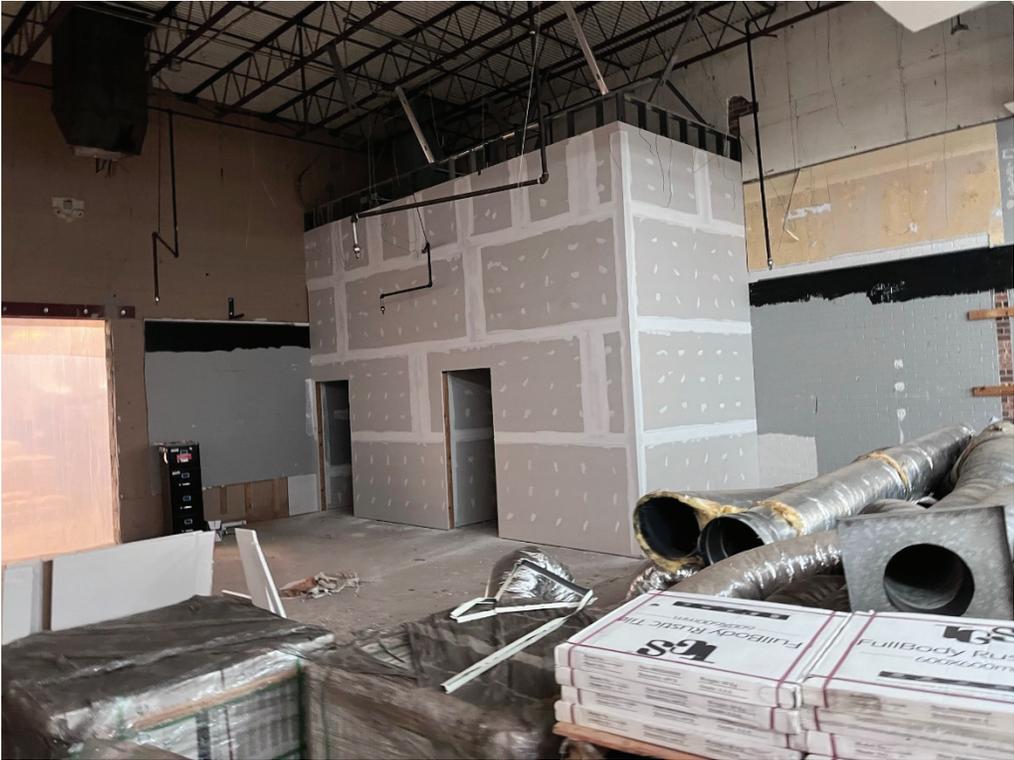
Figure 4 – Interior Mudwork has begun

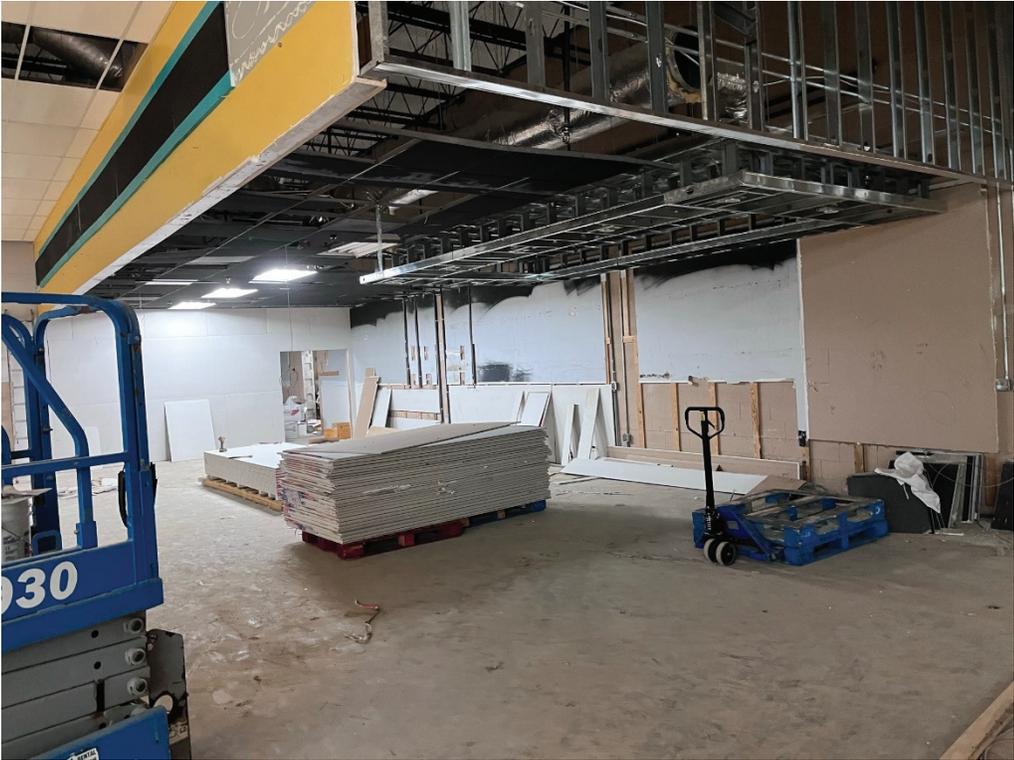
Figure 5 – Stored materials and a framed accent ceiling

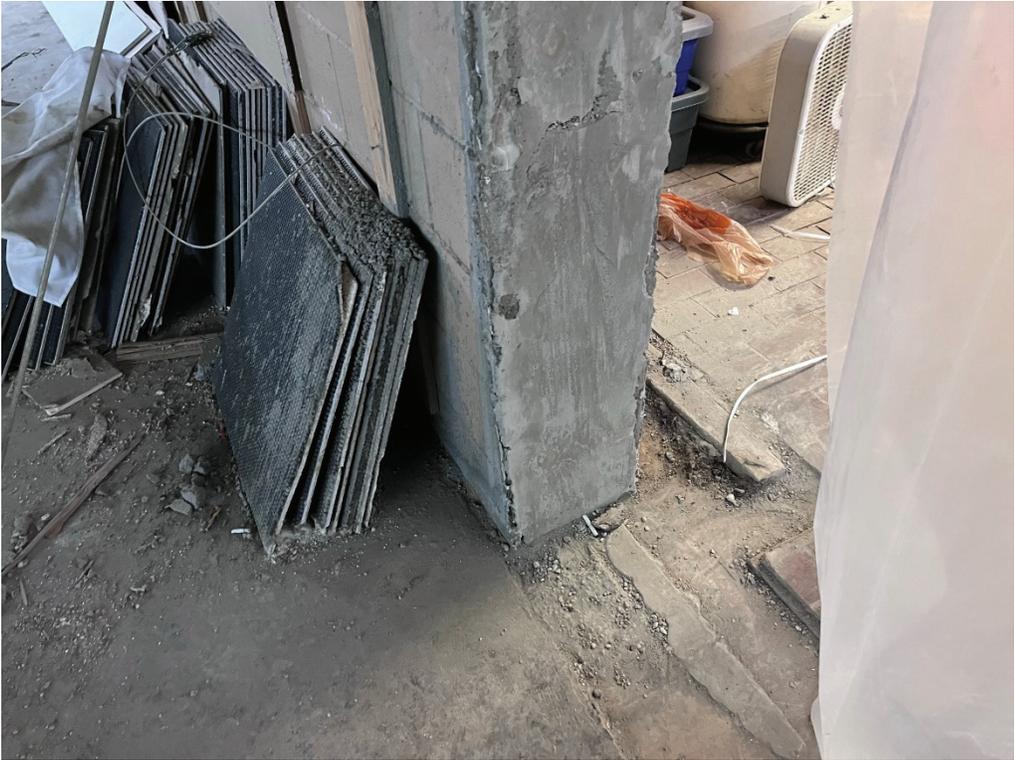
Figure 6 – Mortar has been installed at cut Hollow Block

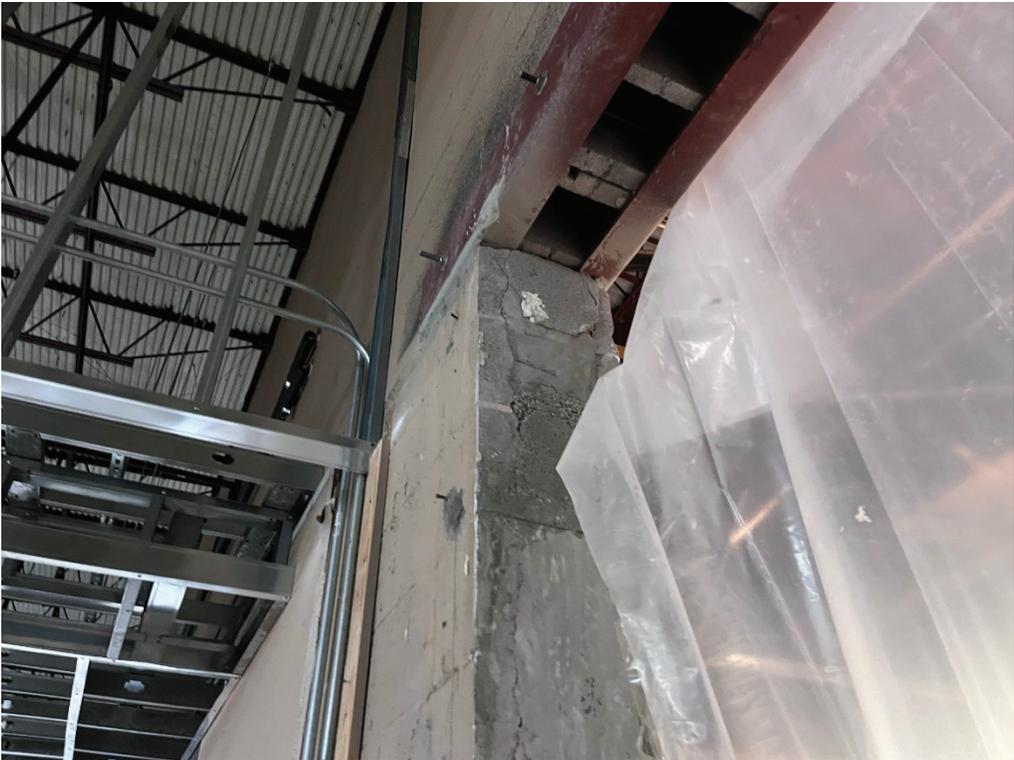
Figure 7 – Mortar has been installed at cut Hollow Block

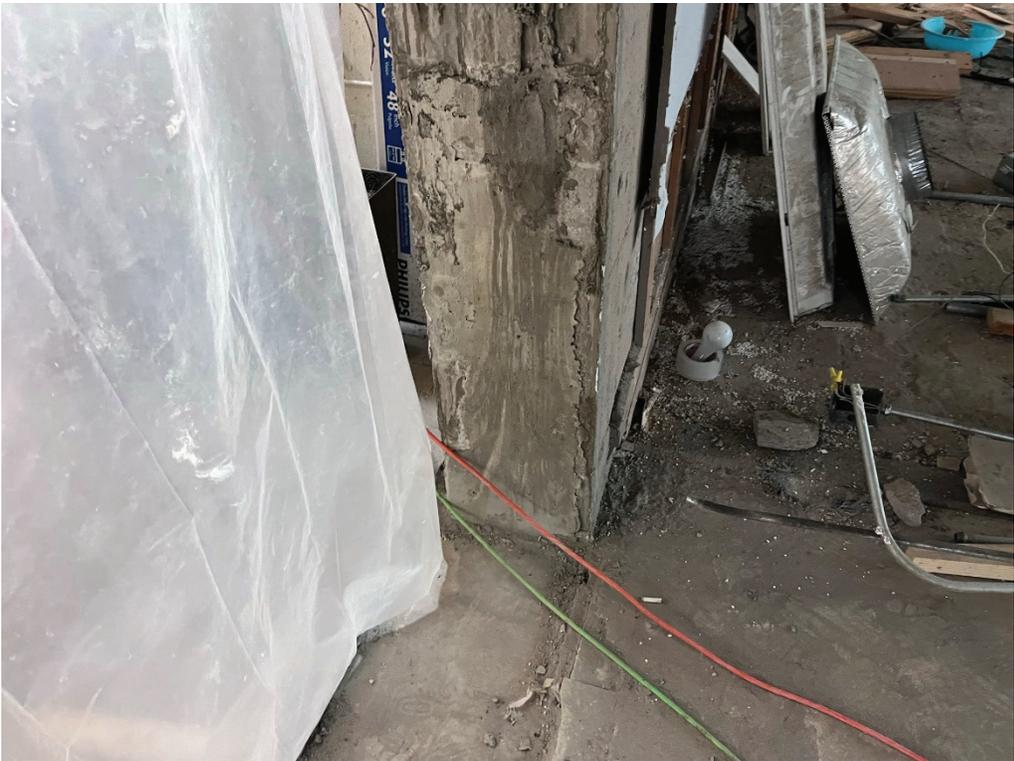
Figure 8 – Mortar has been installed at cut Hollow Block

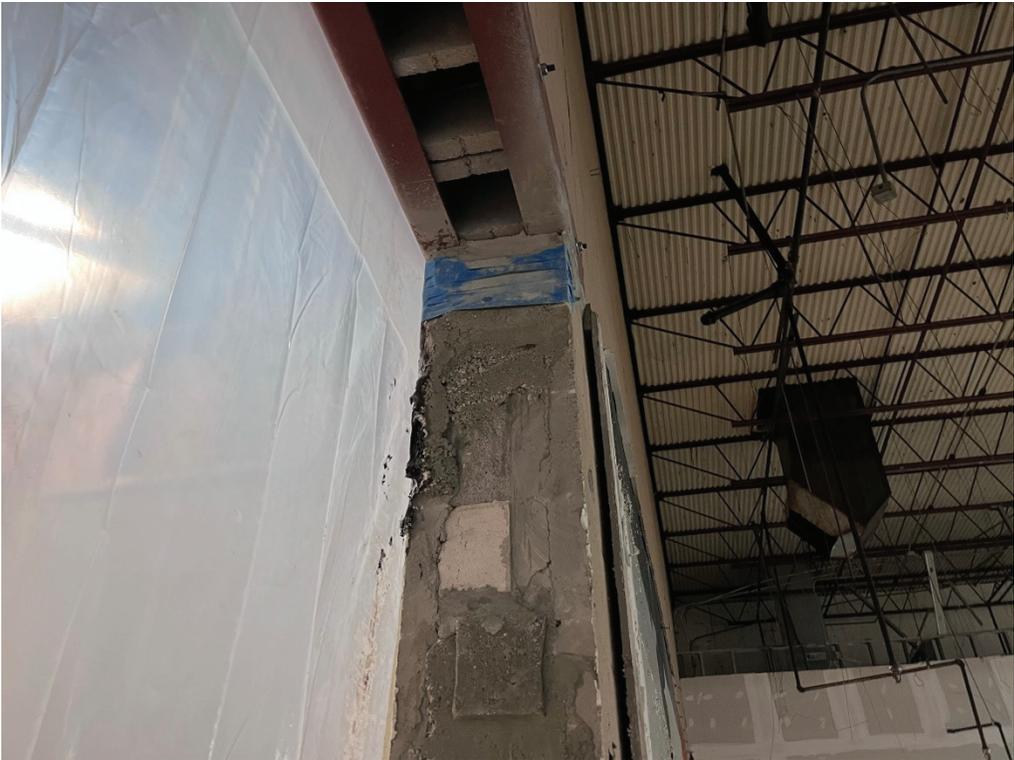
Figure 9 – Mortar has been installed at cut Hollow Block

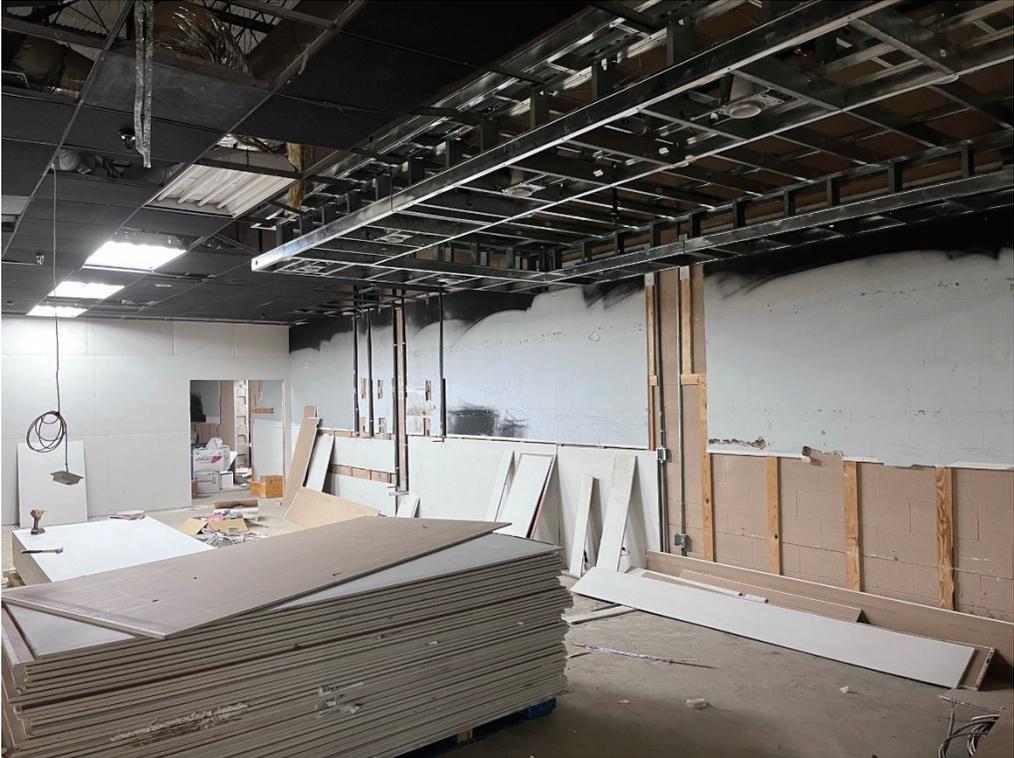
Figure 10 – Framed Accent Ceiling

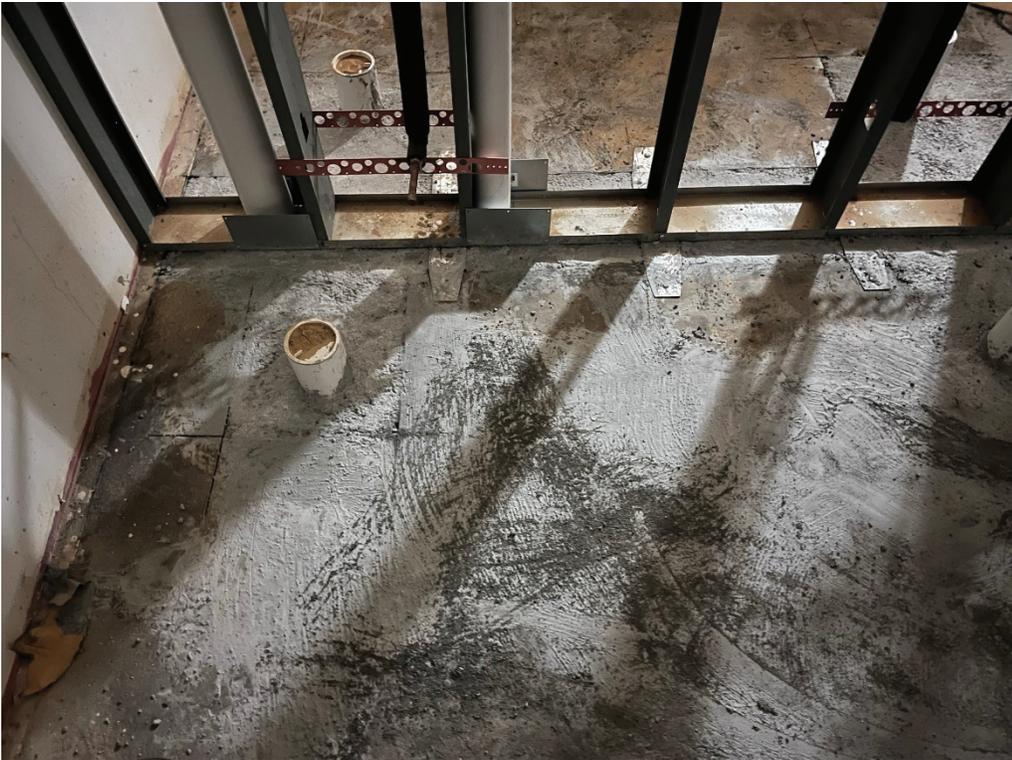
Figure 11 – Excavations have been filled

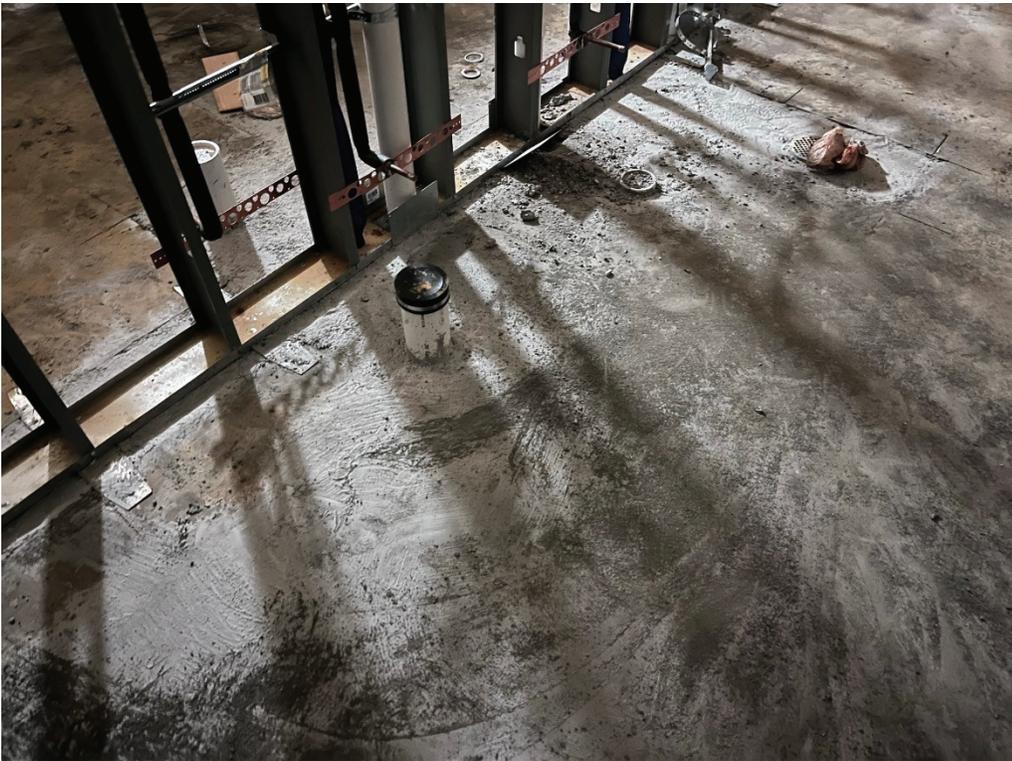
Figure 12 – Excavations have been filled

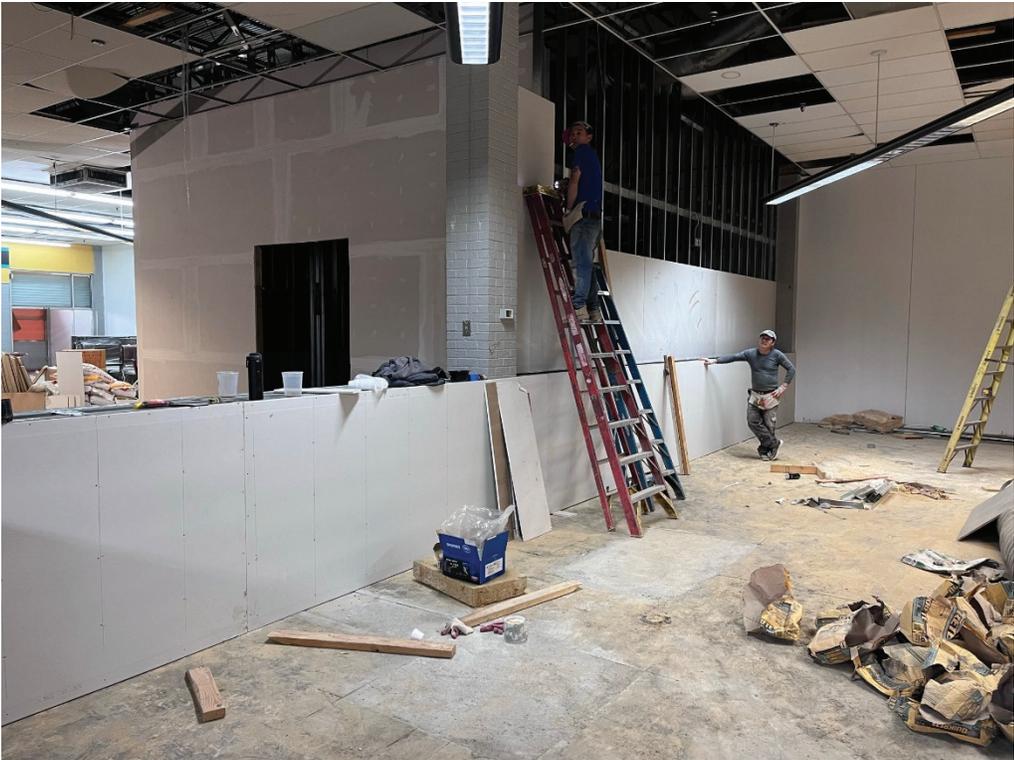
Figure 13 – Drywall Hangers

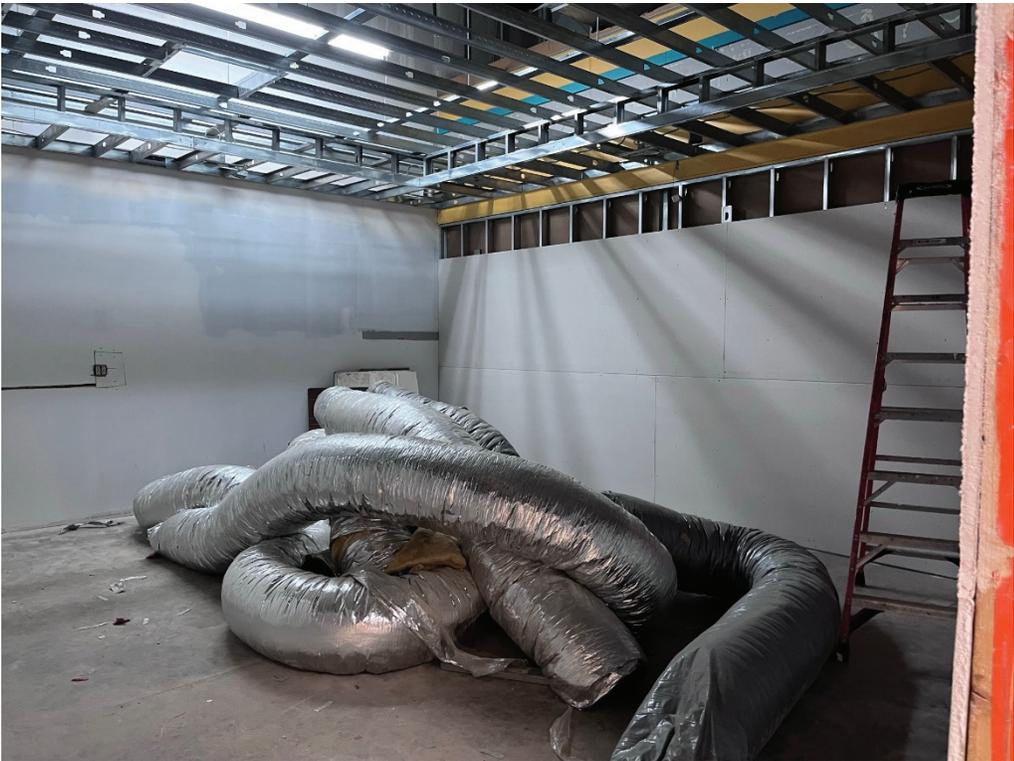
Figure 14 – Ducting work at rear of space

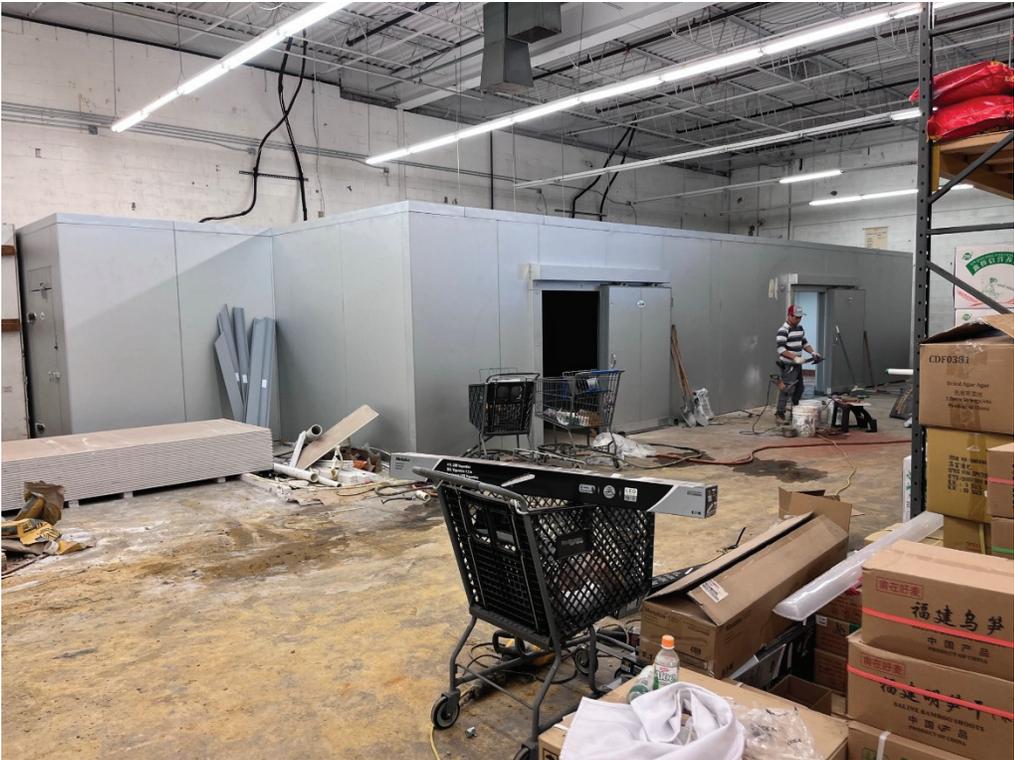
Figure 15 – Newly installed Walk in Cooler

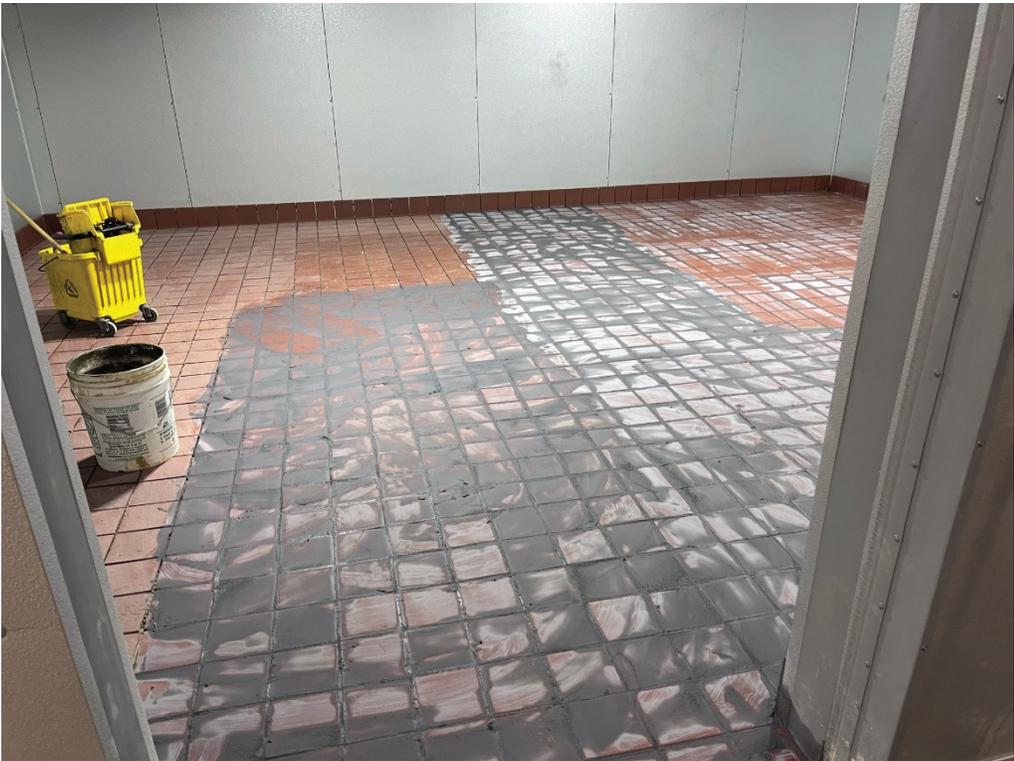
Figure 16 – Tile Work at Walk in Cooler

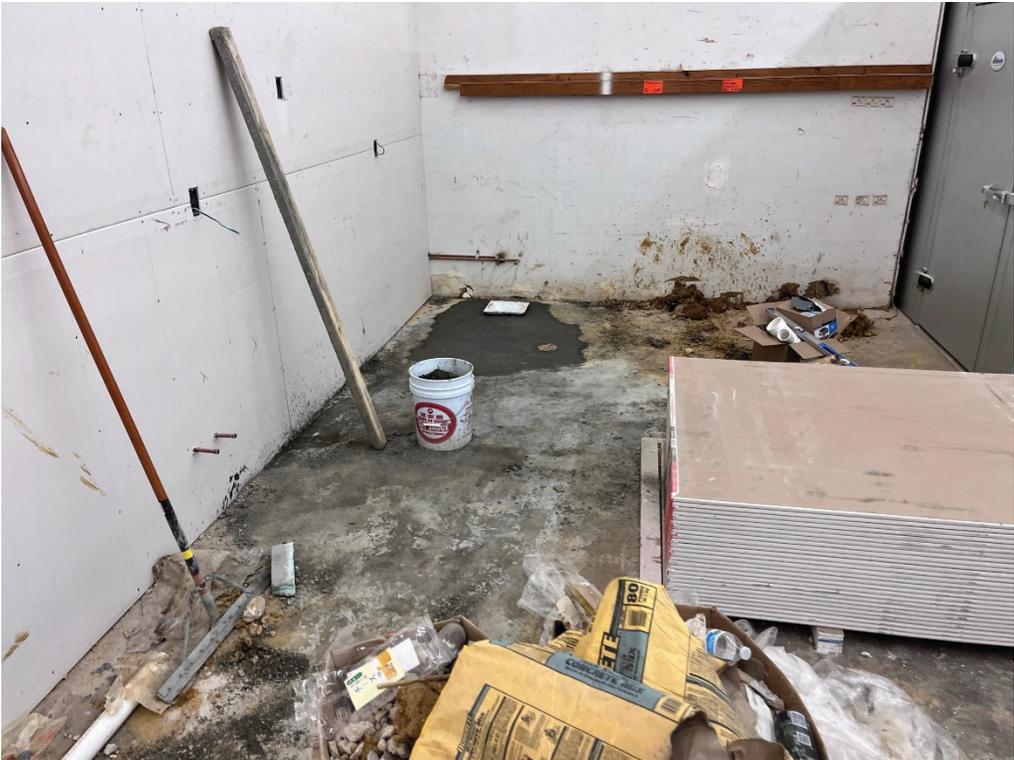
Figure 17 – New Plumbing at warehouse on cooler side of wall

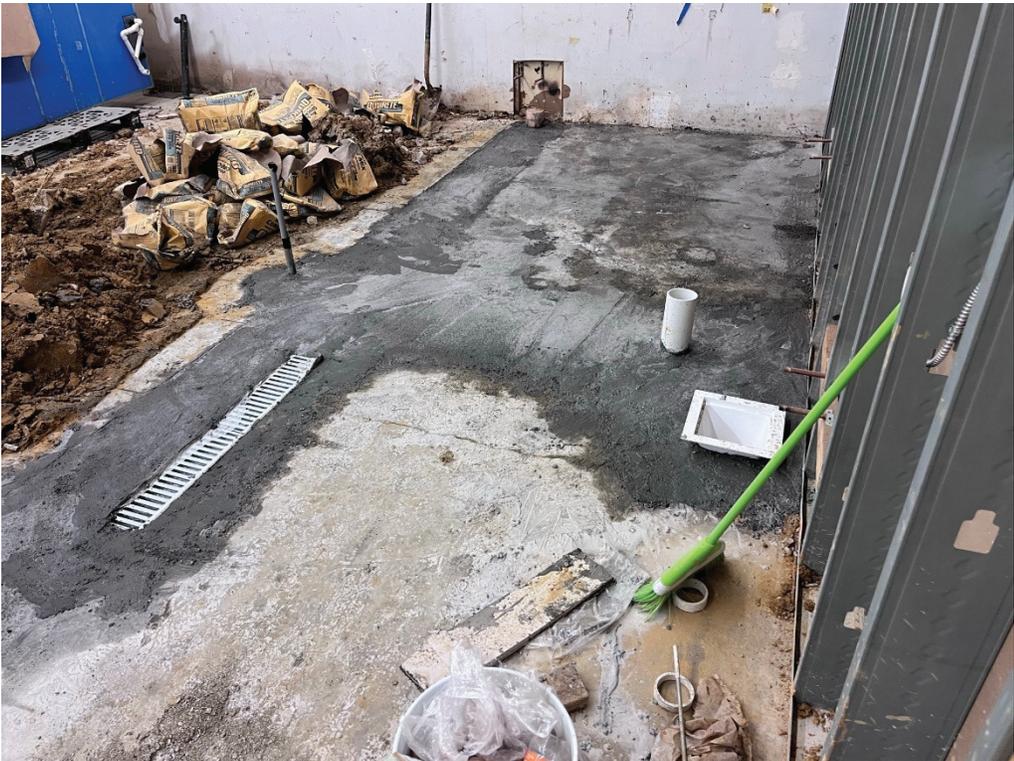
Figure 18 – New Plumbing between Existing Grocery Wall and New Wall

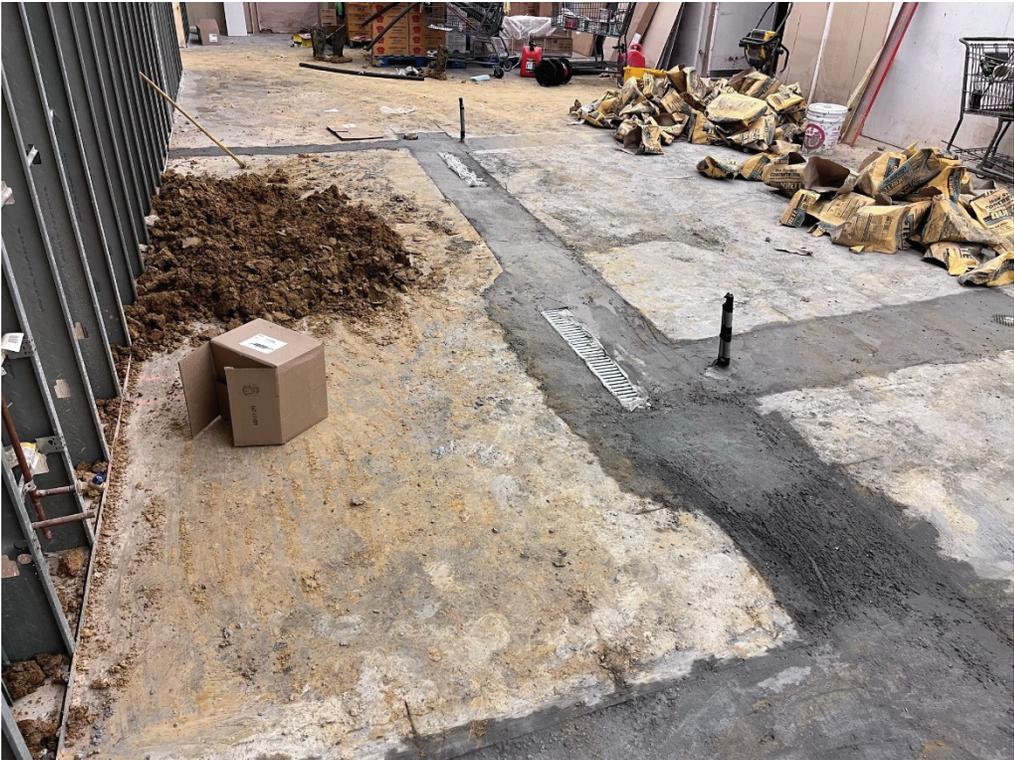
Figure 19 – New Plumbing between Existing Grocery Wall and New Wall

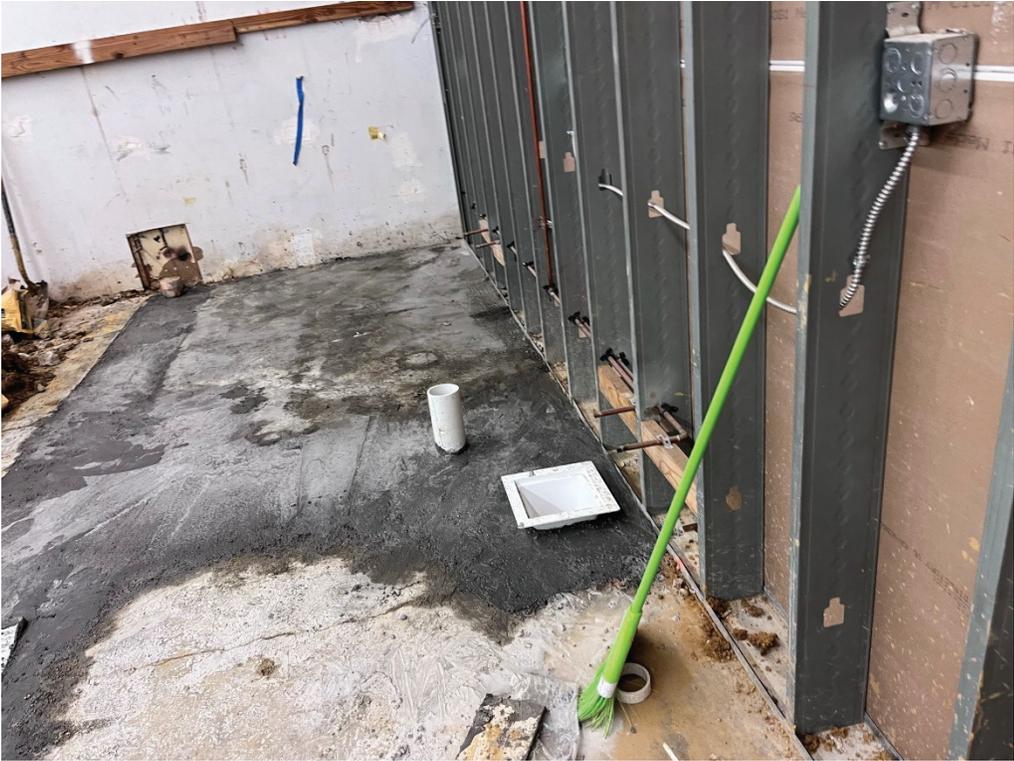
Figure 20 – New Plumbing between Existing Grocery Wall and New Wall
