Wednesday, December 7, 2022

Architect's Field Report

5465 Interstate 55 North Frontage Rd, Jackson, MS 39206

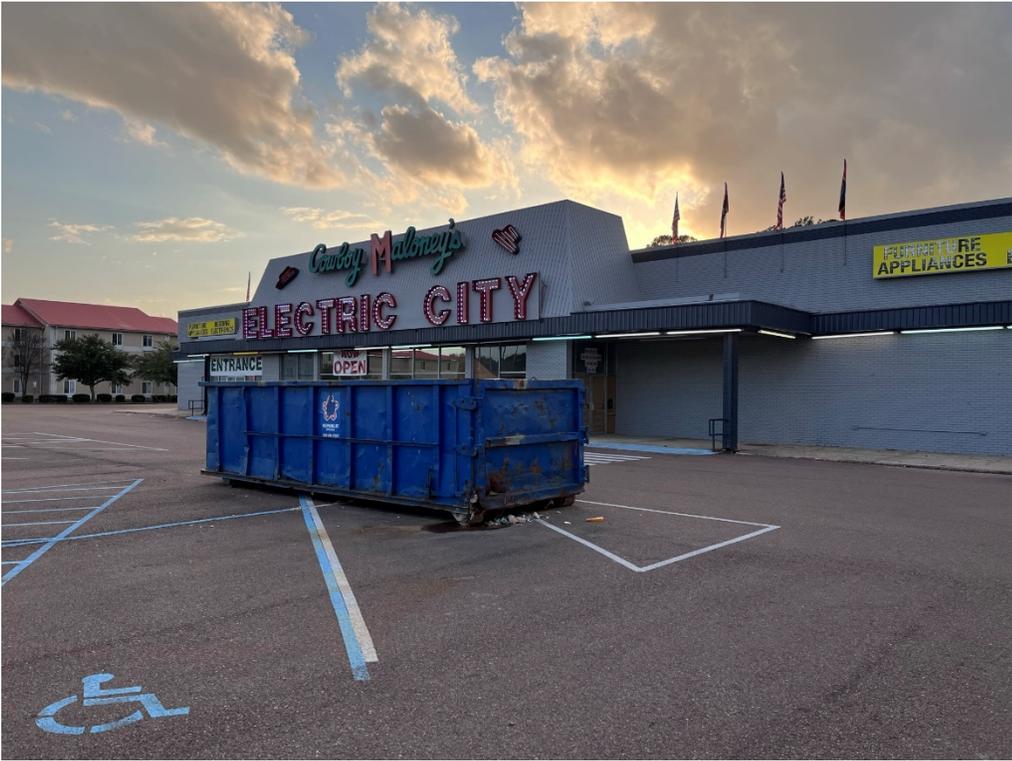
Figure 1 – Property Front

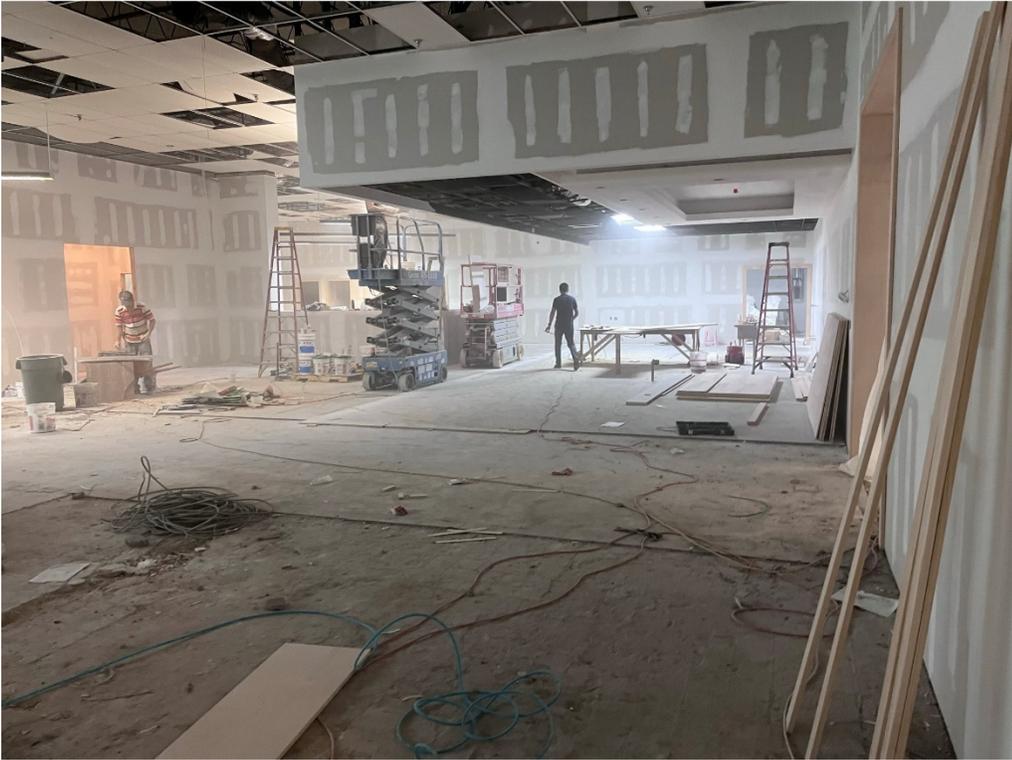
I arrived on the job site at 4:00PM. I entered the store from the grocery side as the door to the renovation side was locked. Drywall finishers were busy sanding mud work inside. Most of the drywall appeared complete.

Figure 2 – Interior Mud work currently being sanded

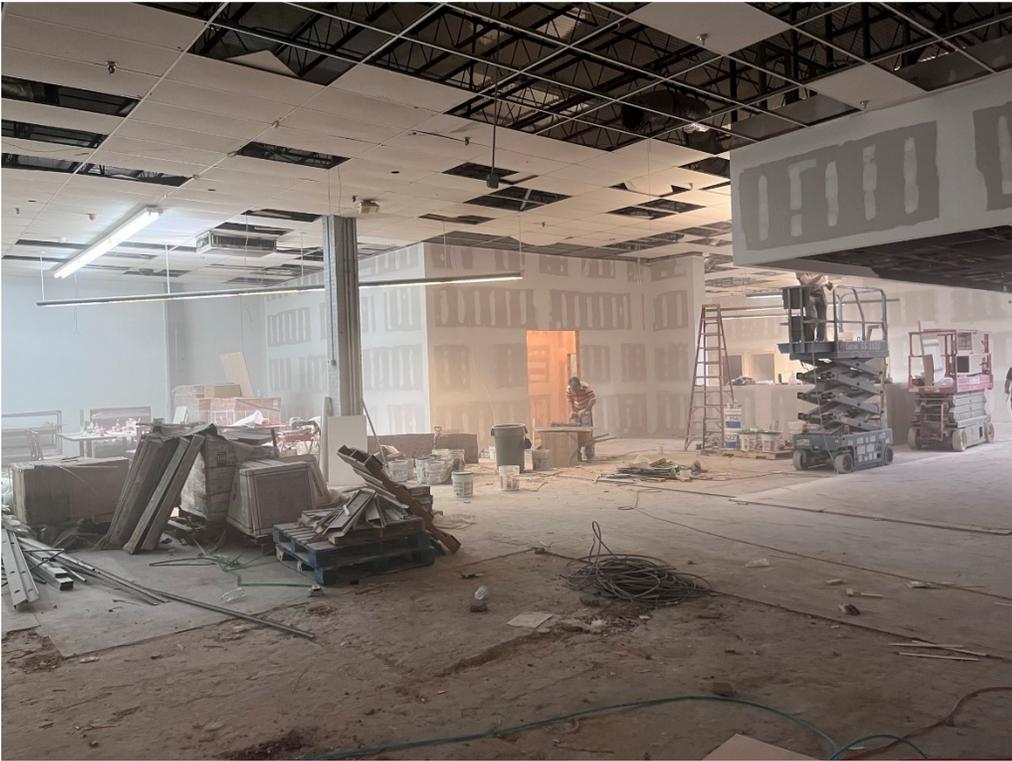
Ceiling grid was for the most part installed entirely throughout. It appeared straight and flush and in good order.

Figure 3 – Ceiling Grid Installed at Perimeter

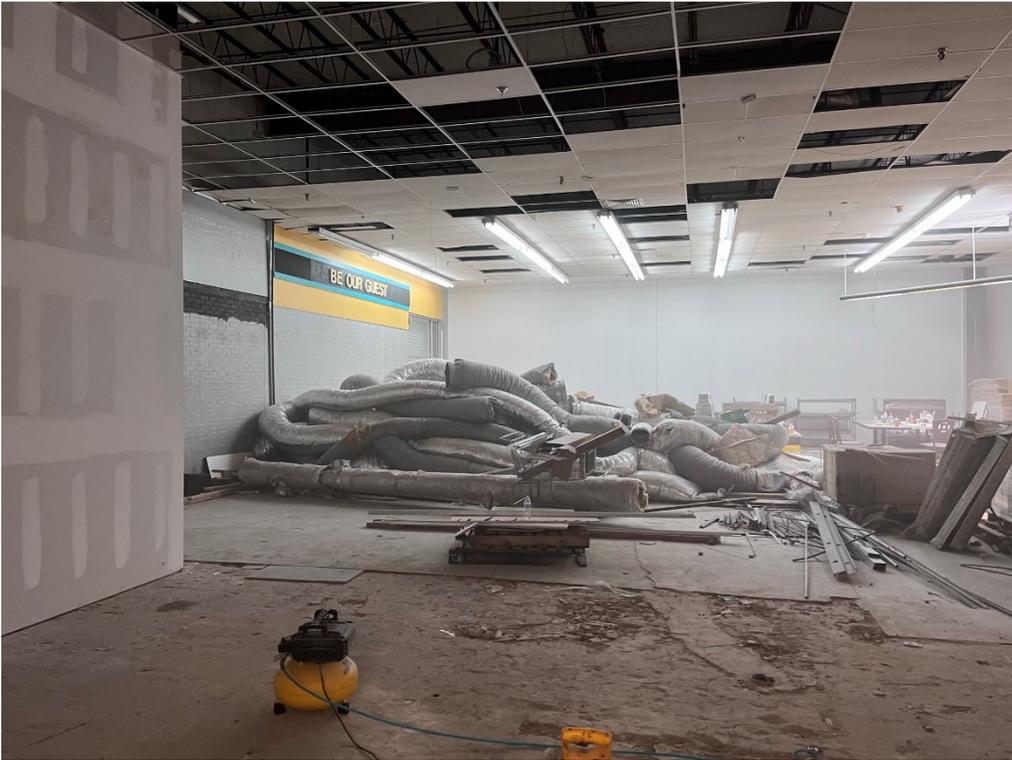
Figure 4 – Ceiling Grid Installed at Perimeter

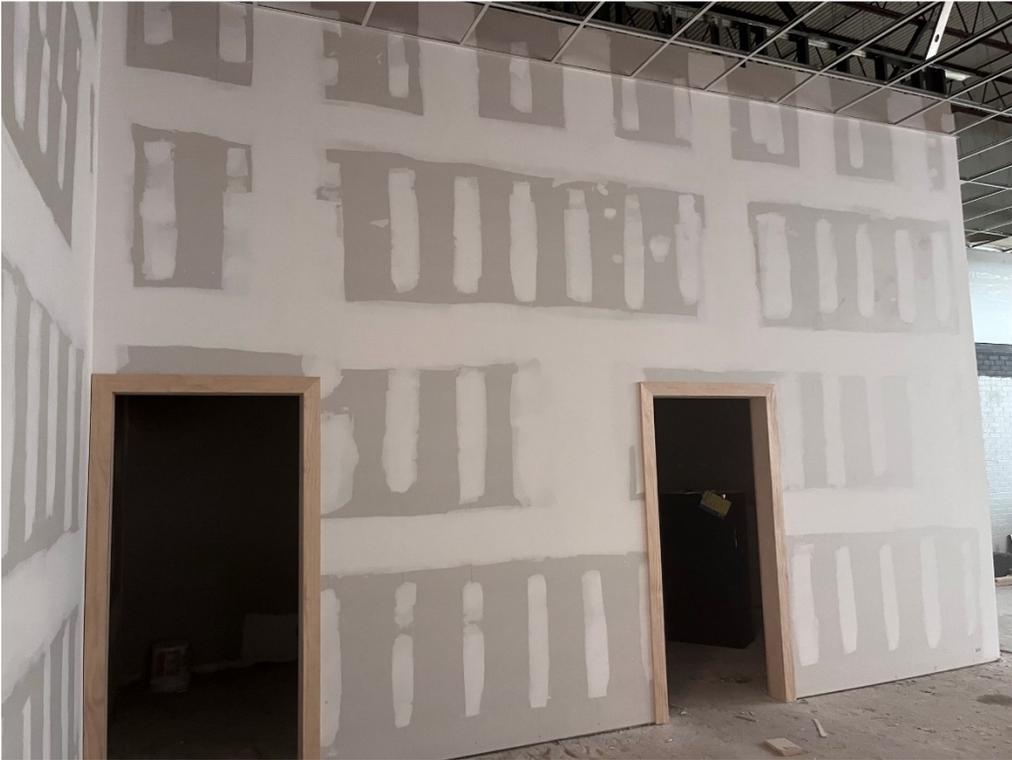
A carpenter was also on site, installing door jambs and casing for all openings. It appeared that the majority of openings were complete. His craftsmanship look to be in good order. I do want to note that he was using plywood instead of solid wood for door jambs which could delaminate over time. The plywood was also a different wood specie from the door casings, but if these are to be painted, the end result should look the same.

Figure 5 – Trimmed Openings

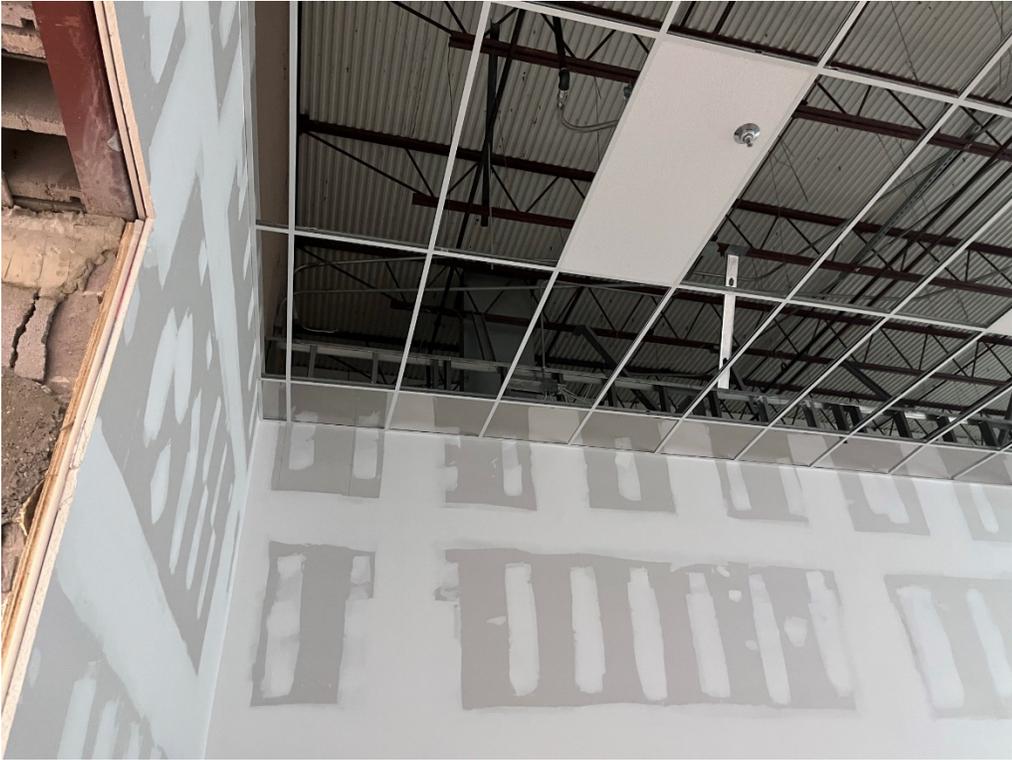
Figure 6 – Ceiling Grid Installed at Perimeter

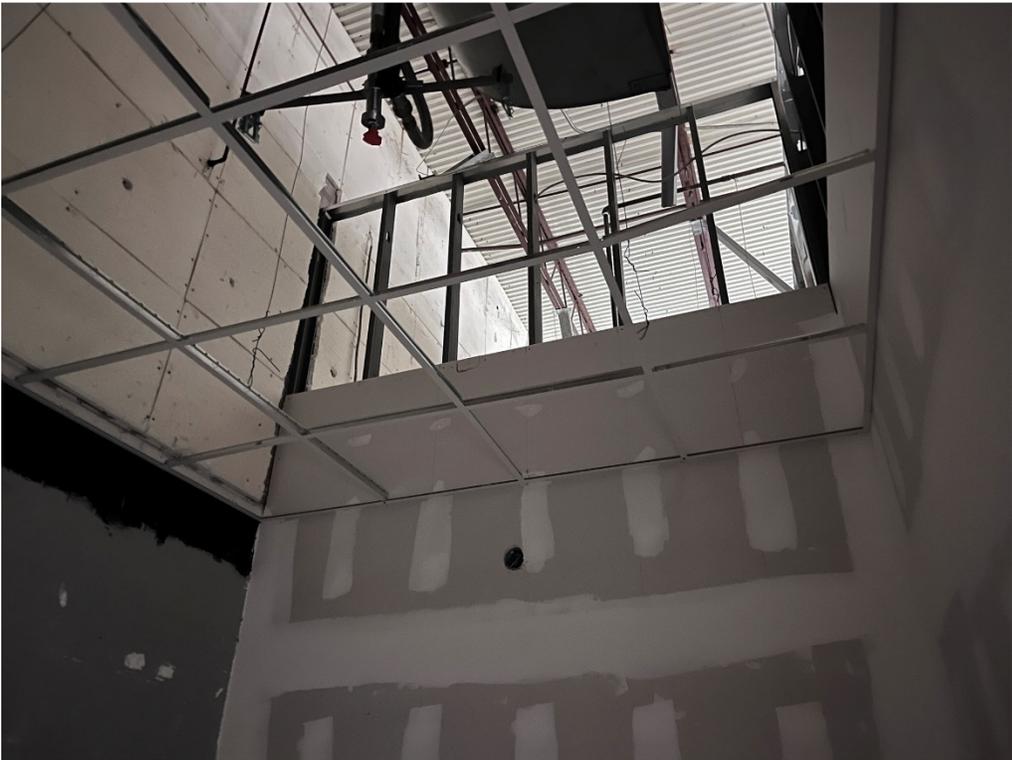
Figure 7 – Ceiling Grid Installed at Perimeter

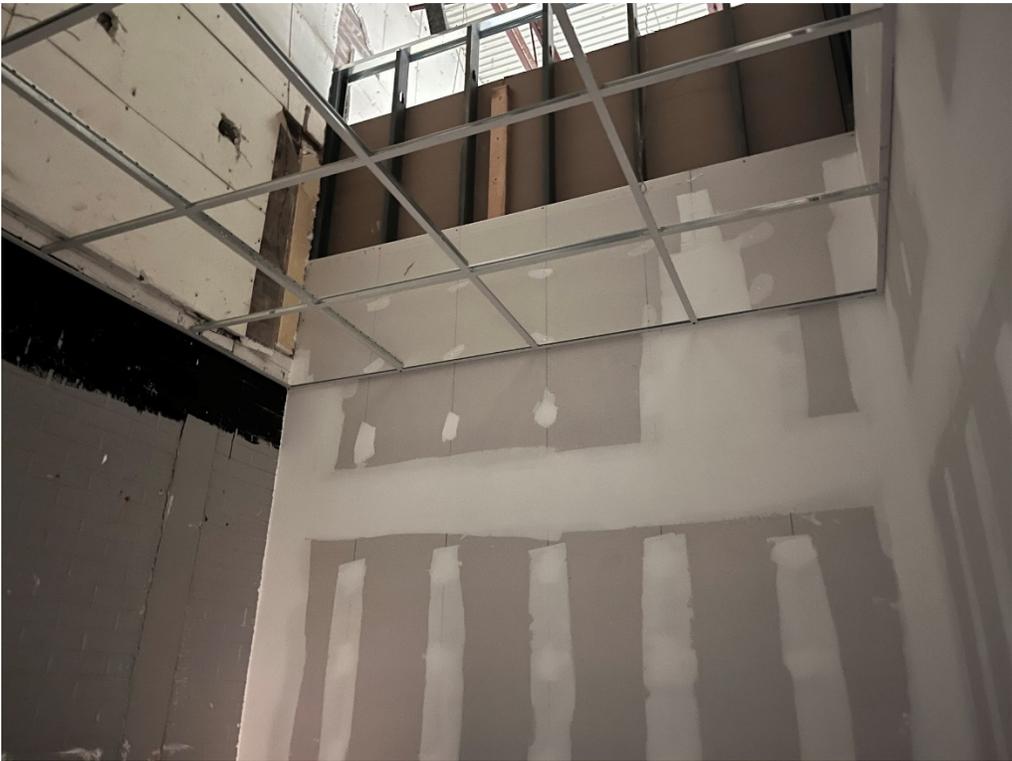
Figure 8 – Ceiling Grid Installed at Perimeter

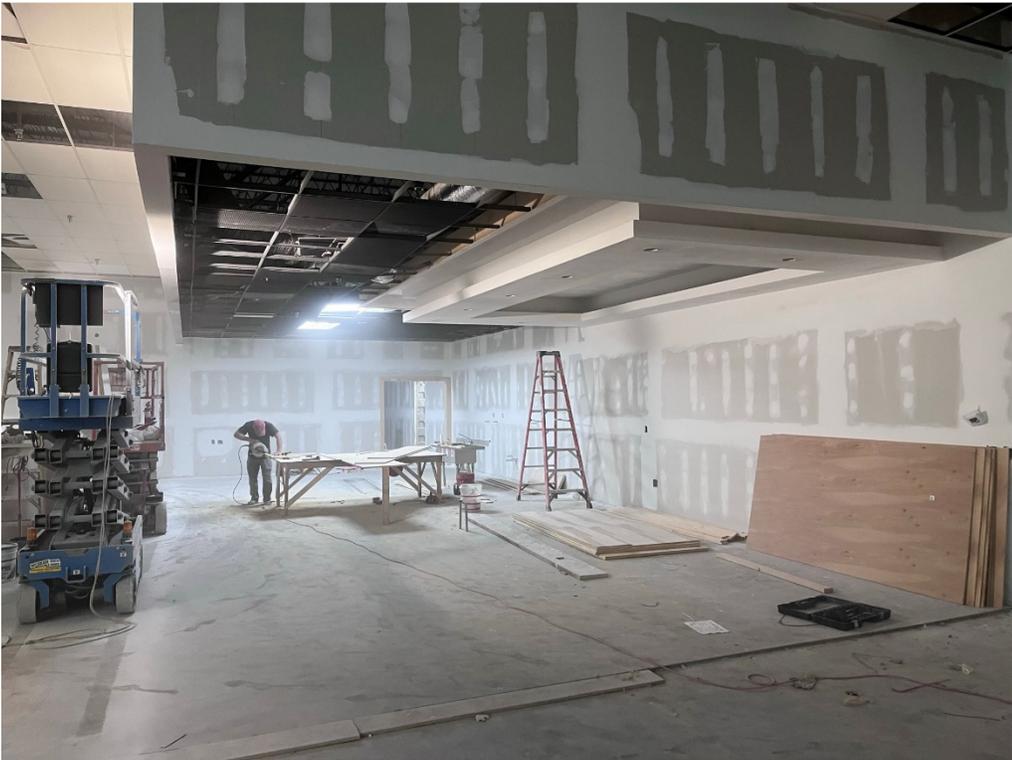
Figure 9 – Sanded Drywall

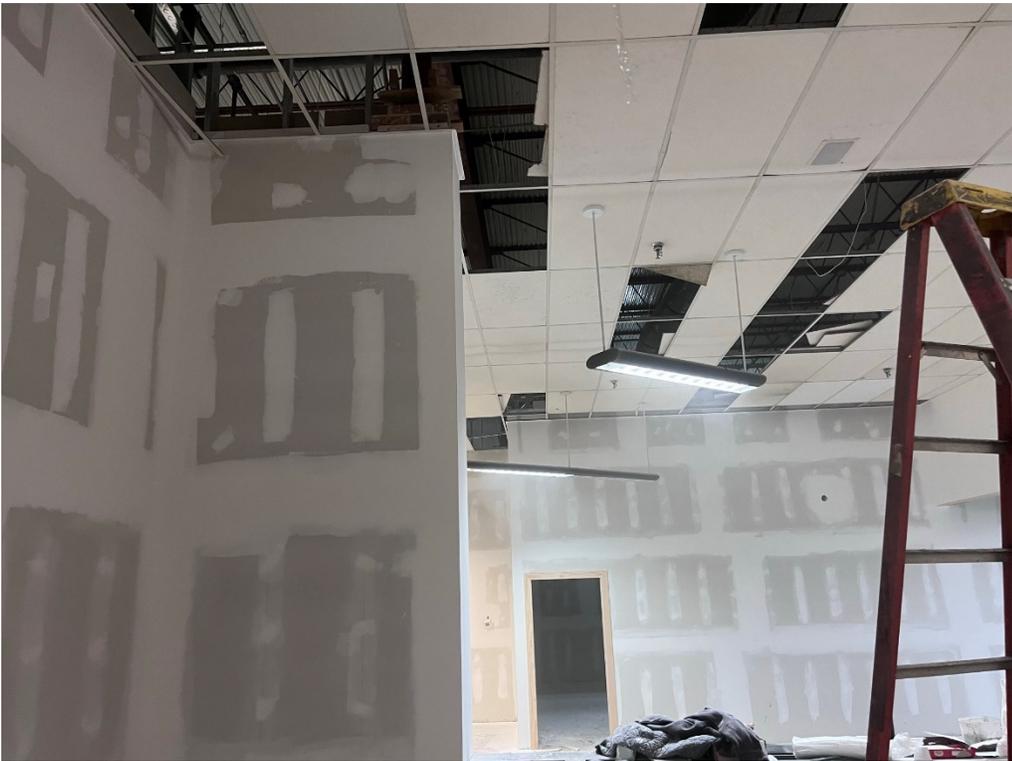
Figure 10 – Ceiling Grid Installed at Perimeter

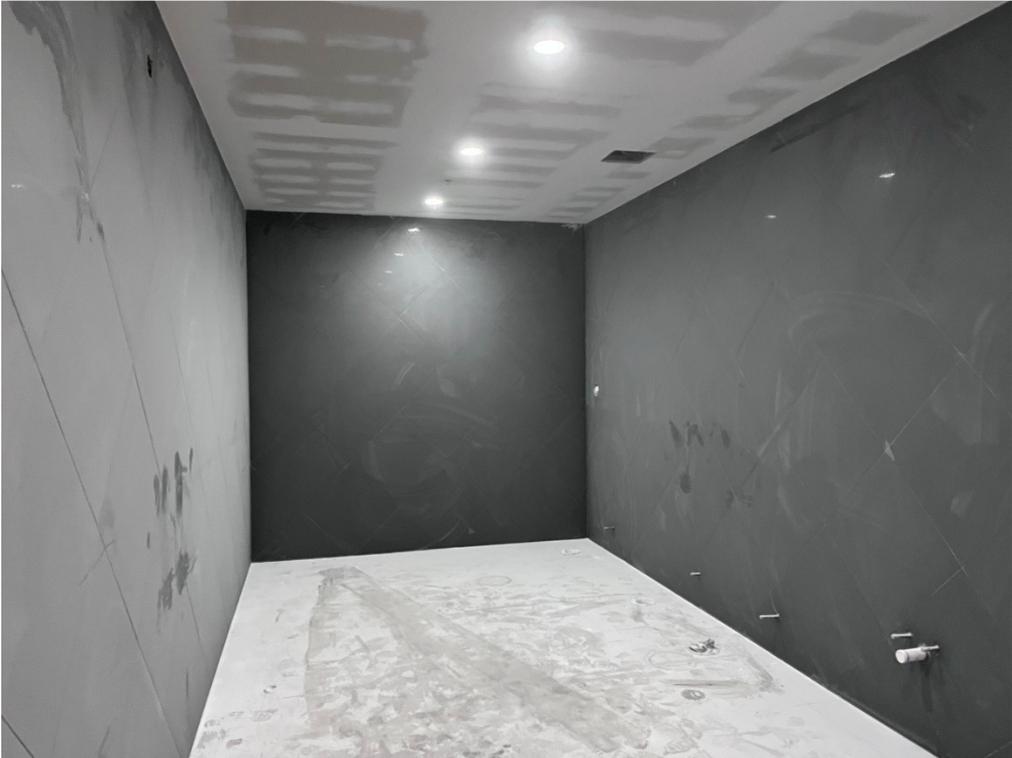
In the toilet rooms, installers were placing tiles on wall surfaces. This installation appears to be flush and straight.

Figure 11 – Tile Installed at Toilet Room

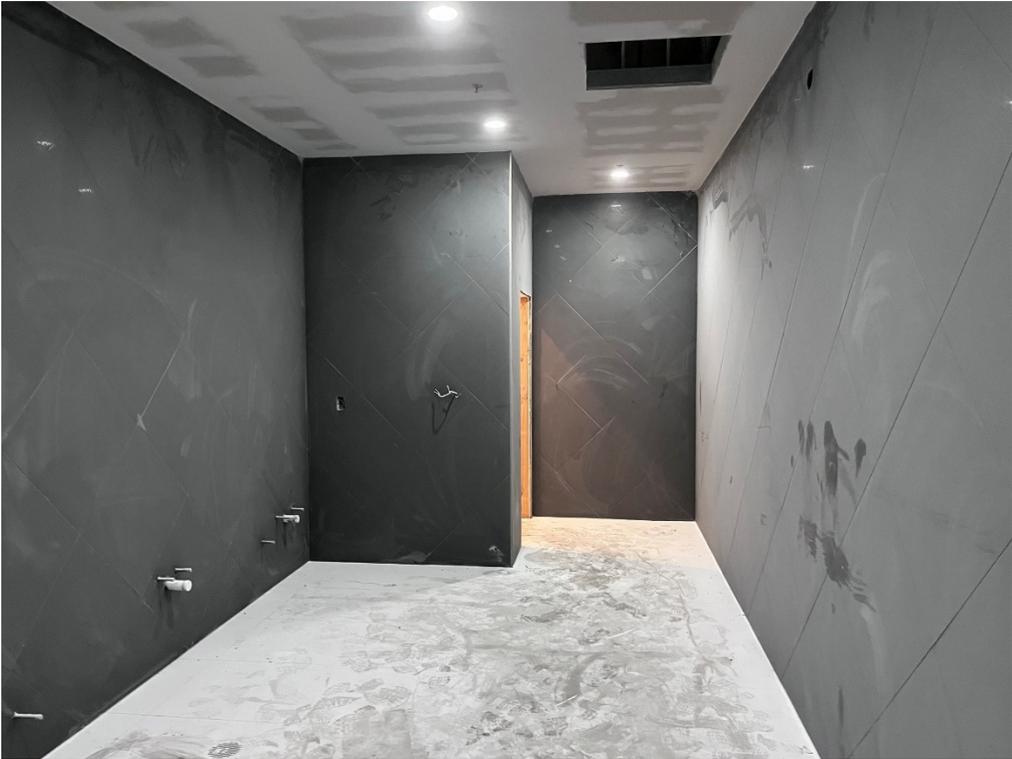
Figure 12 – Tile Installed at Toilet Room

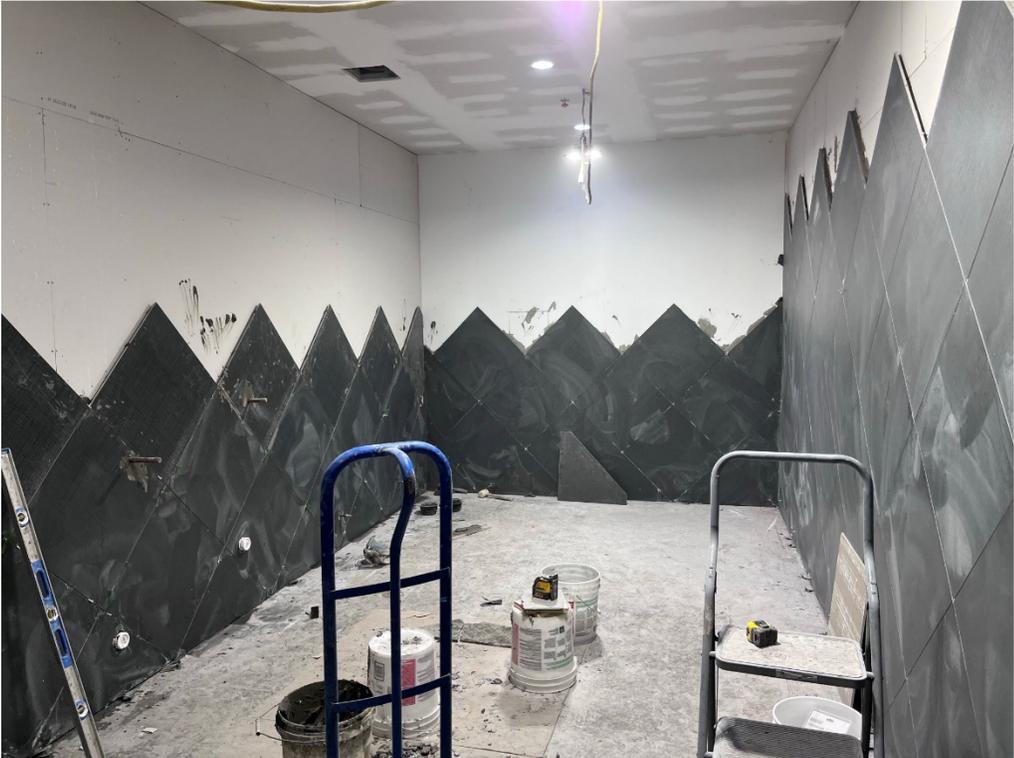
Figure 13 – Tile Partially Installed at Toilet Room

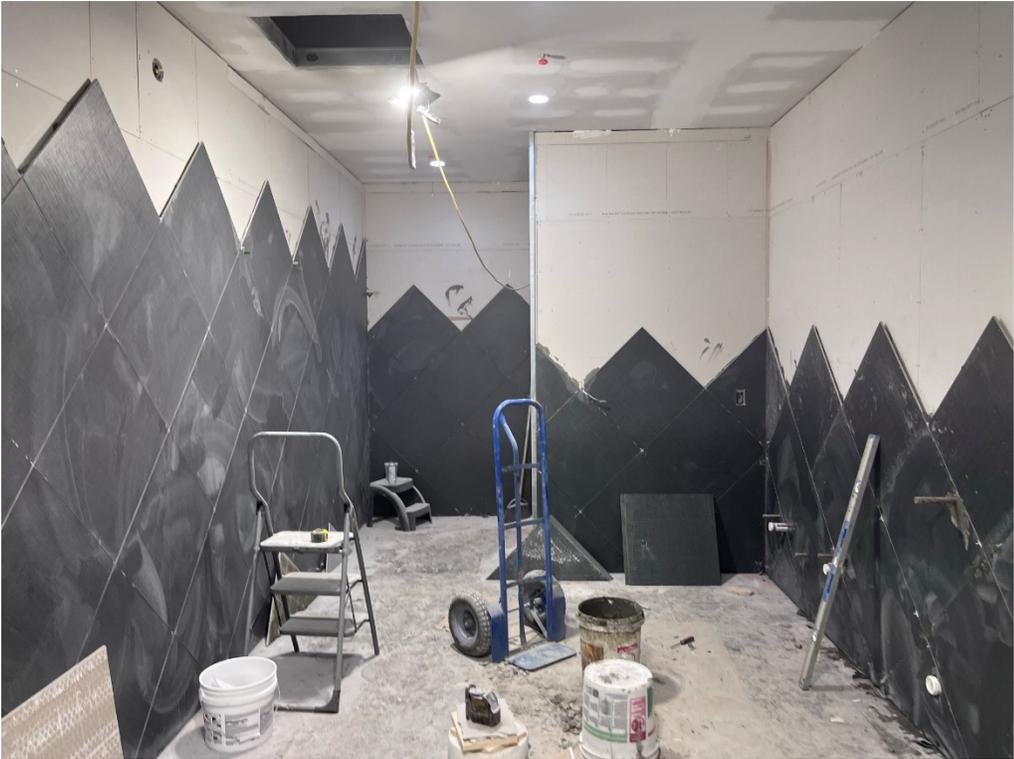
Figure 14 – Tile Partially Installed at Toilet Room

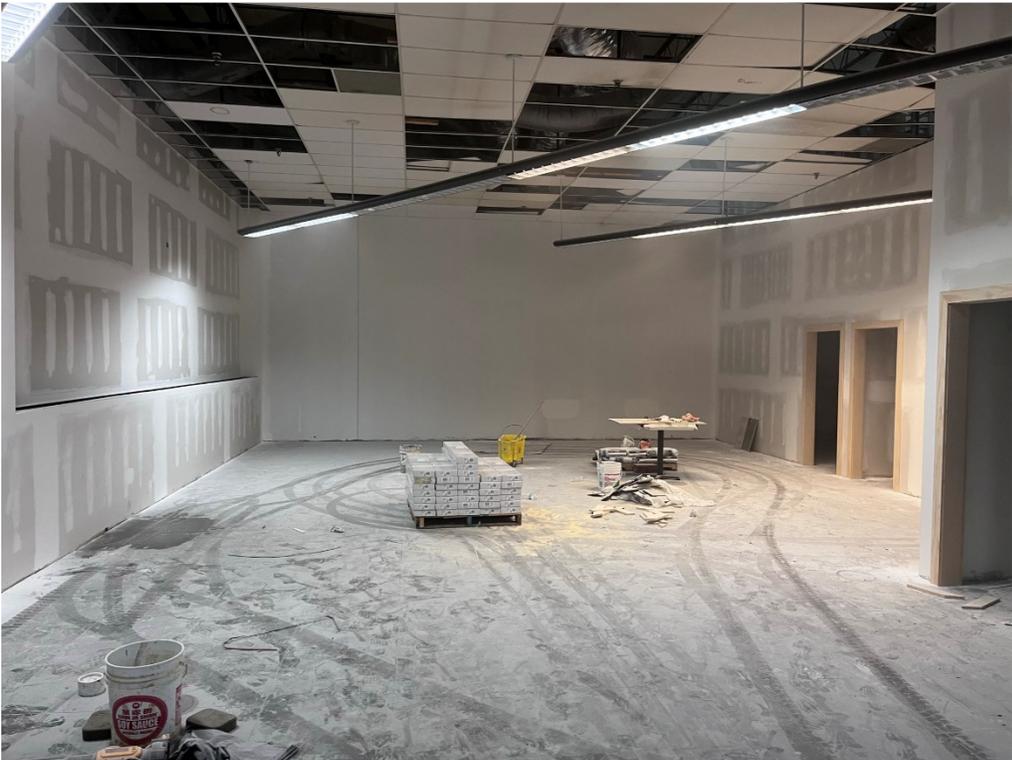
Figure 15 – Sanded Drywall

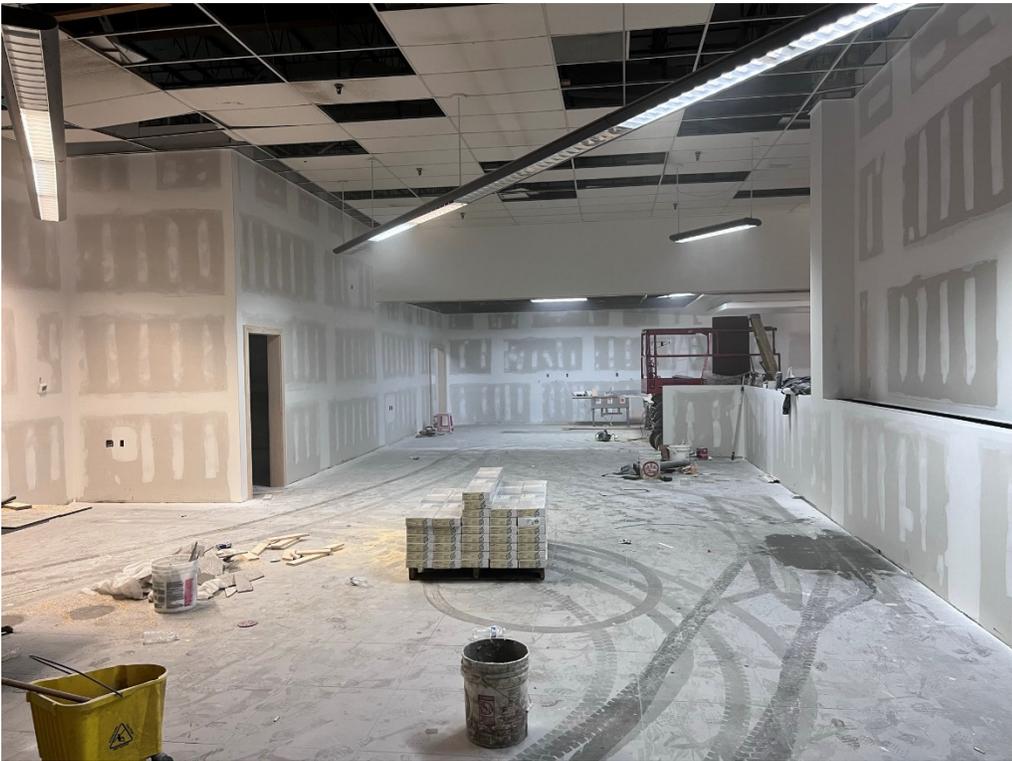
Figure 16 – Sanded Drywall

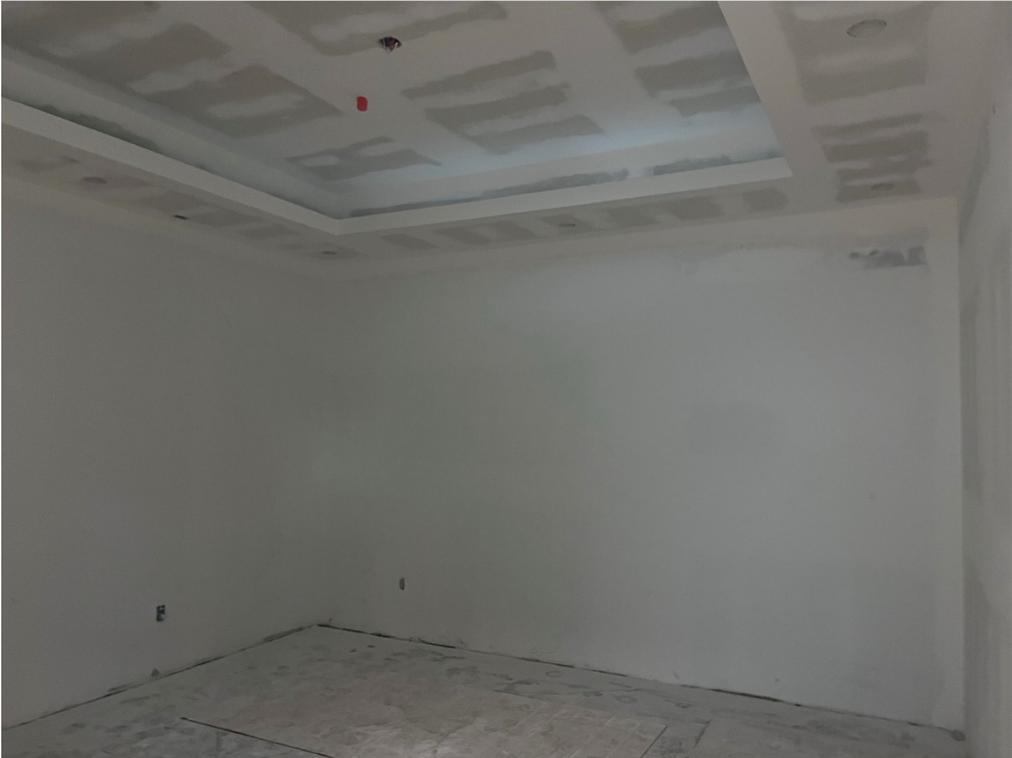
Figure 17 – Sanded Back Room

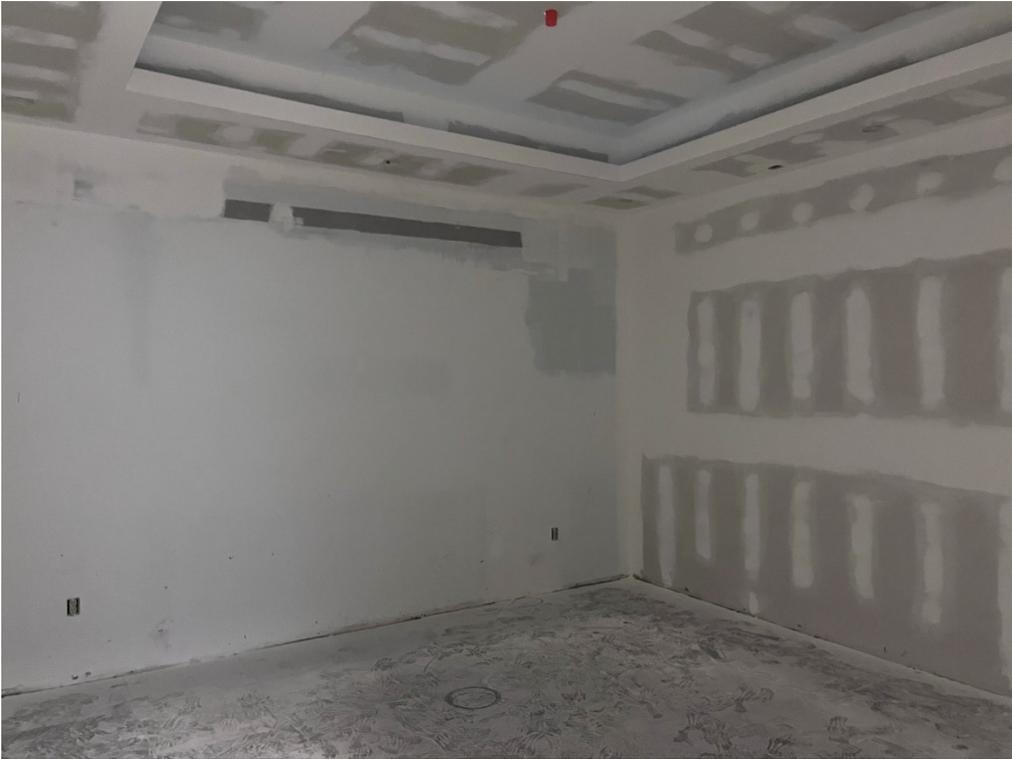
Figure 18 – Sanded Back Room

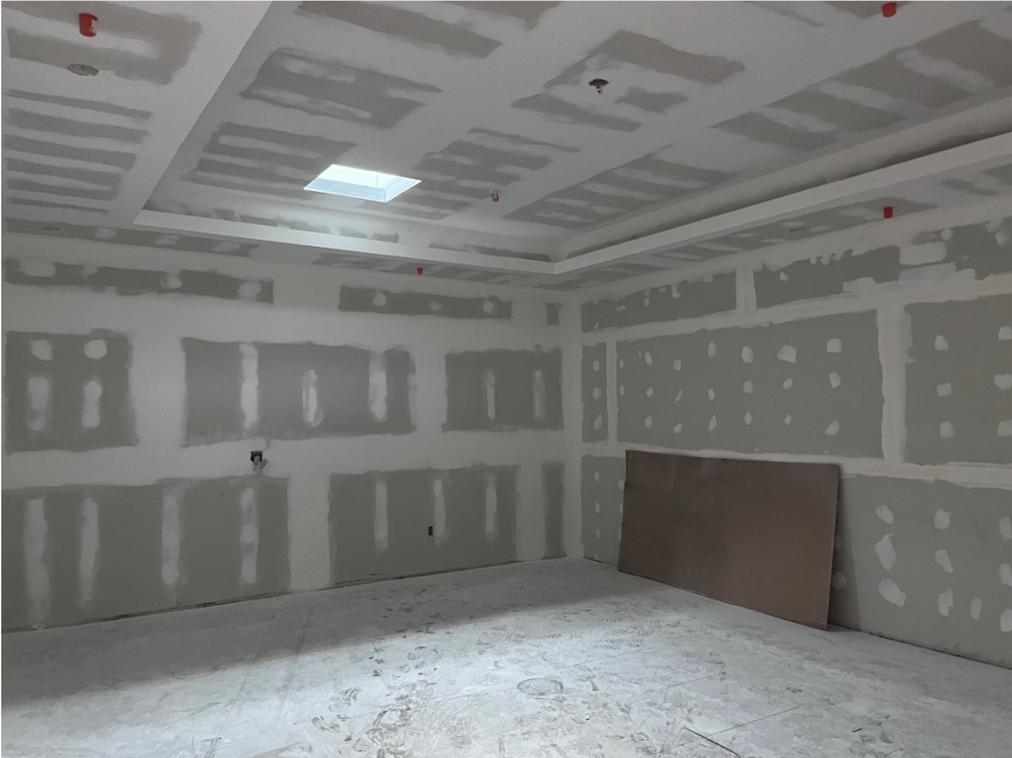
Figure 19 – Sanded Back Room

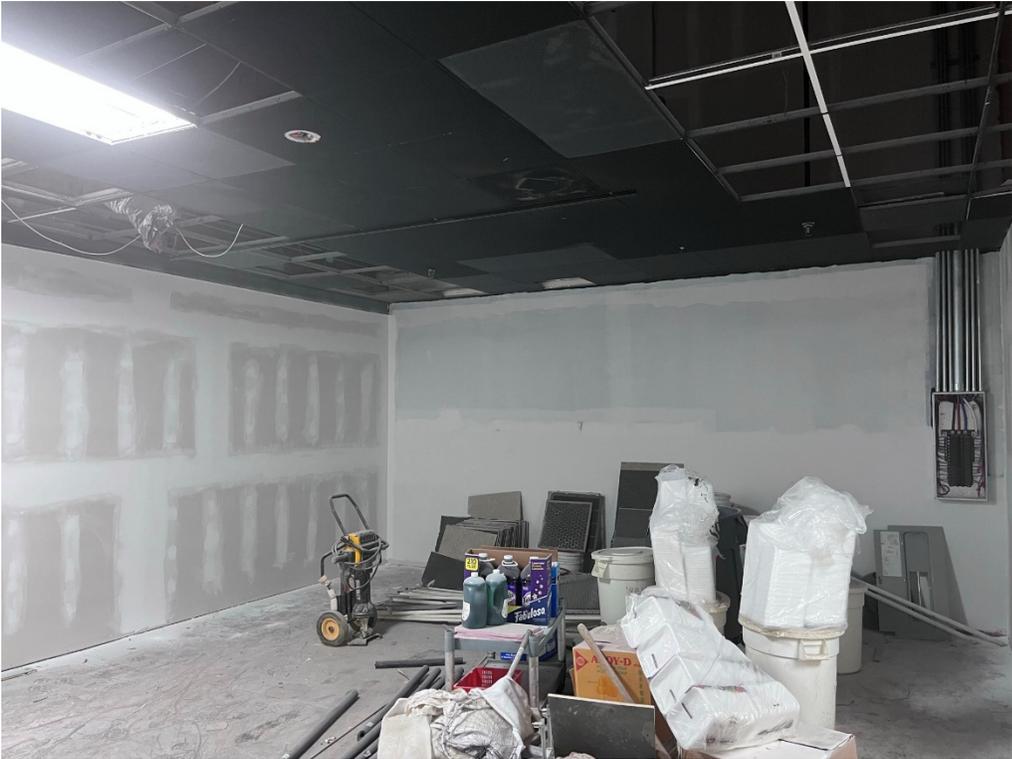
Figure 20 – Sanded Back Room

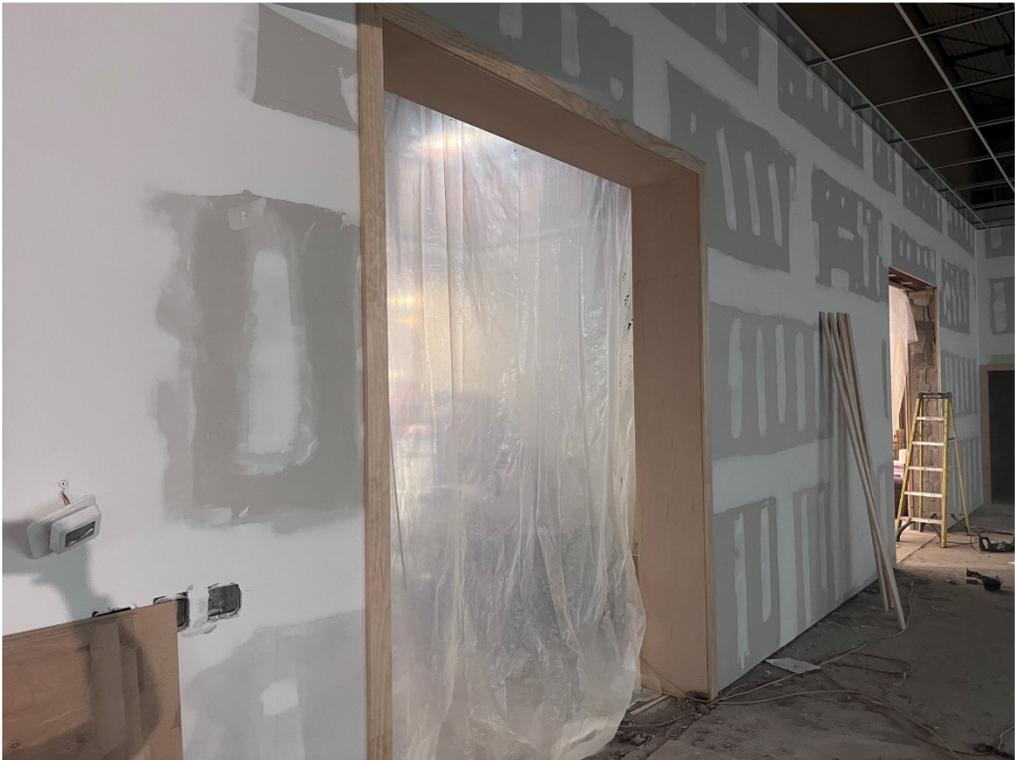
Figure 21 – Trimmed Large Opening

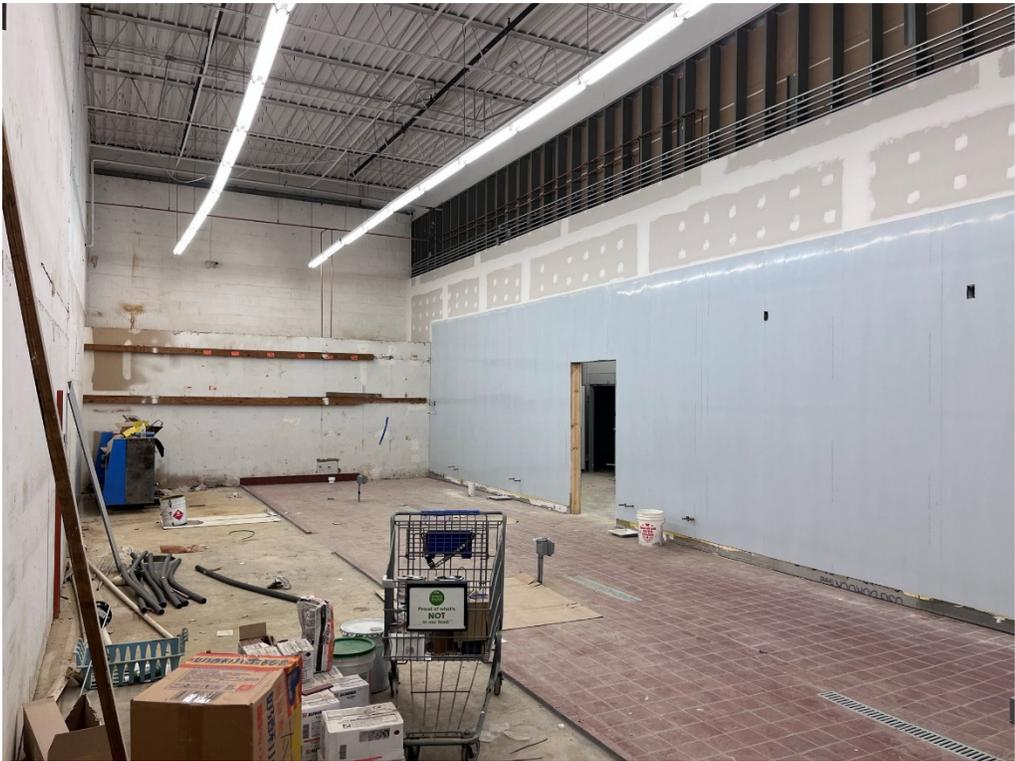
Figure 22 – Wall Panels Installed in Seafood Cleaning Area

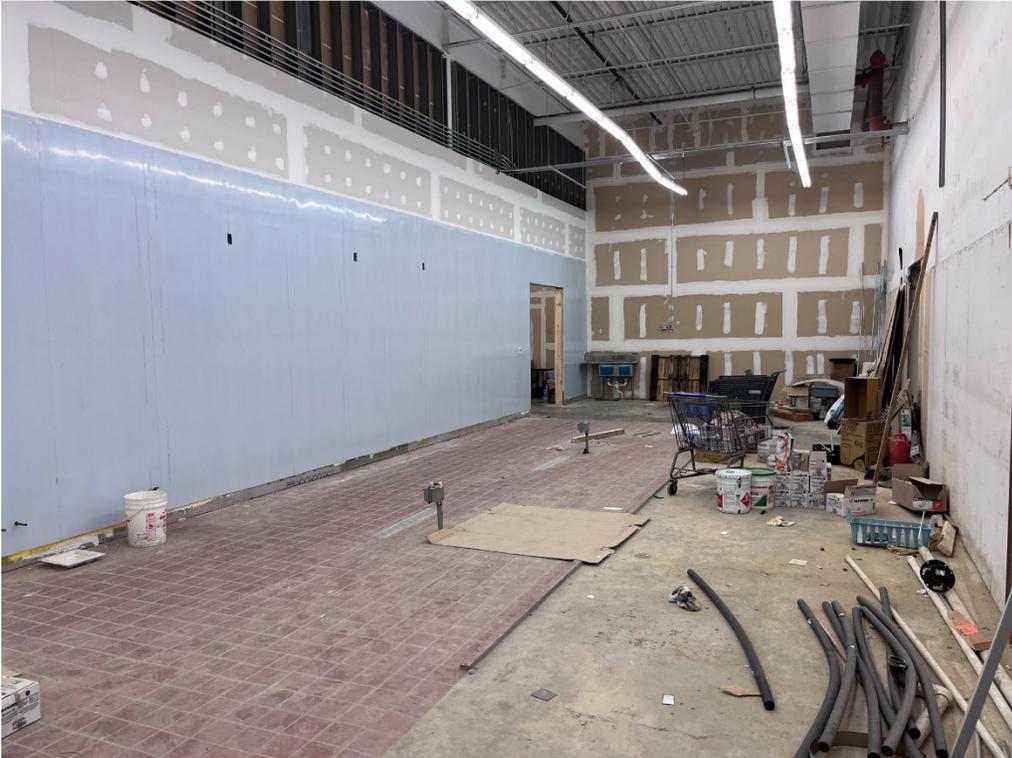
Figure 23 – Wall Panels Installed in Seafood Cleaning Area

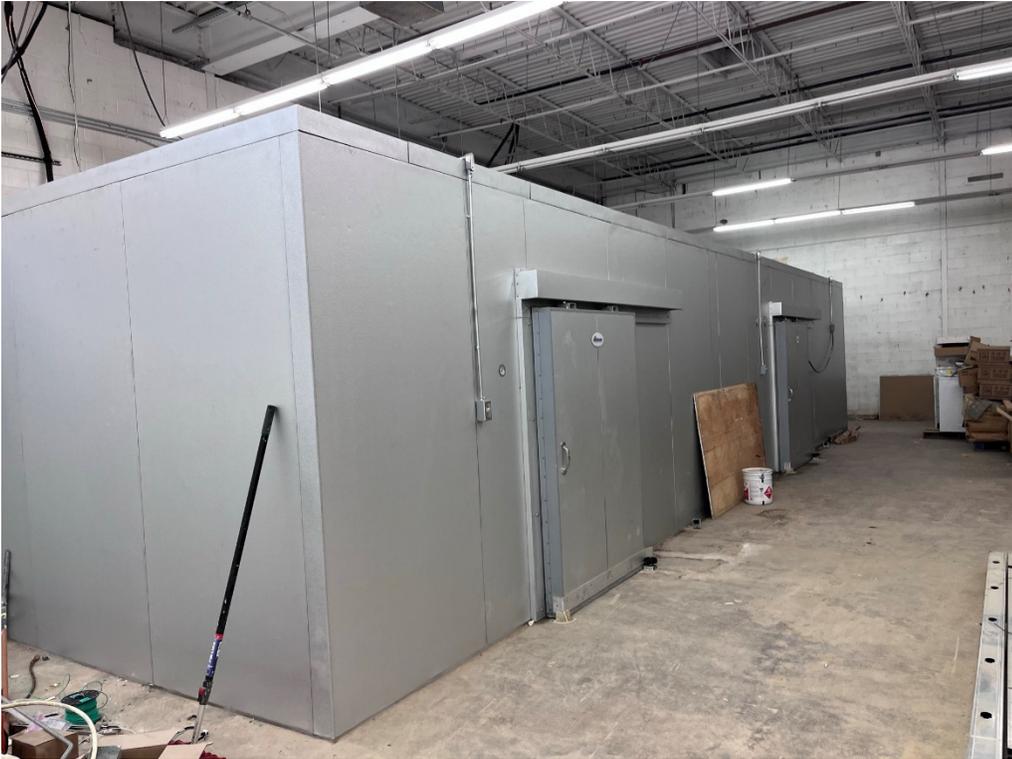
Figure 24 – Cooler is Operational and in Use

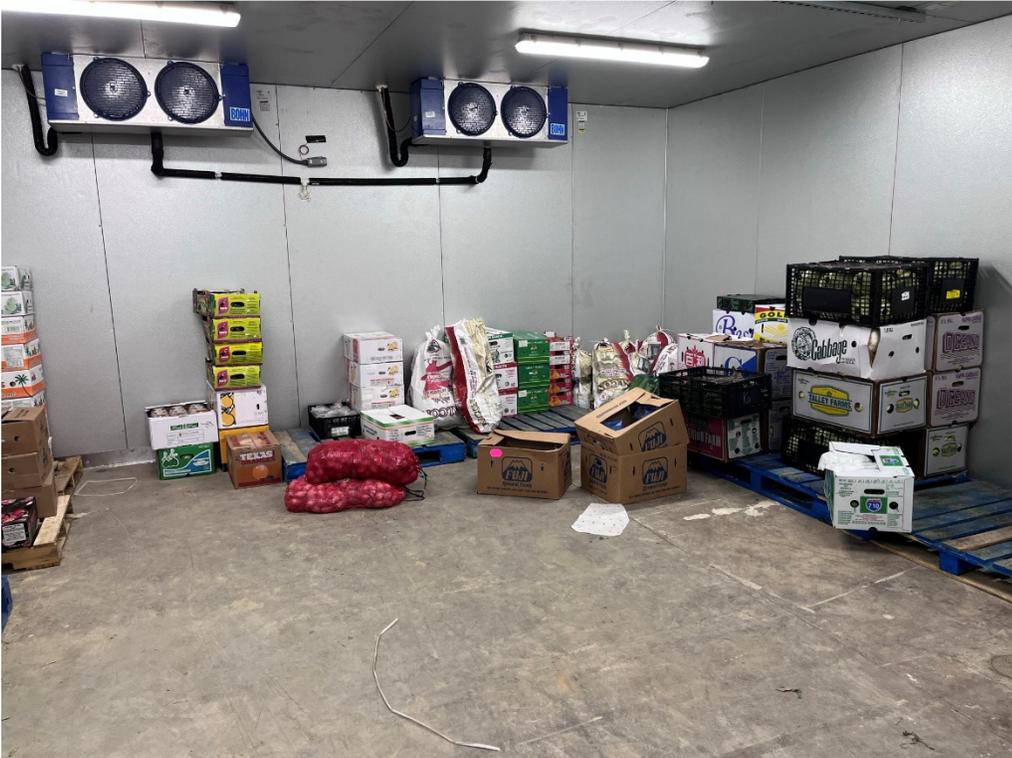
Figure 25 – Refrigerator Operational

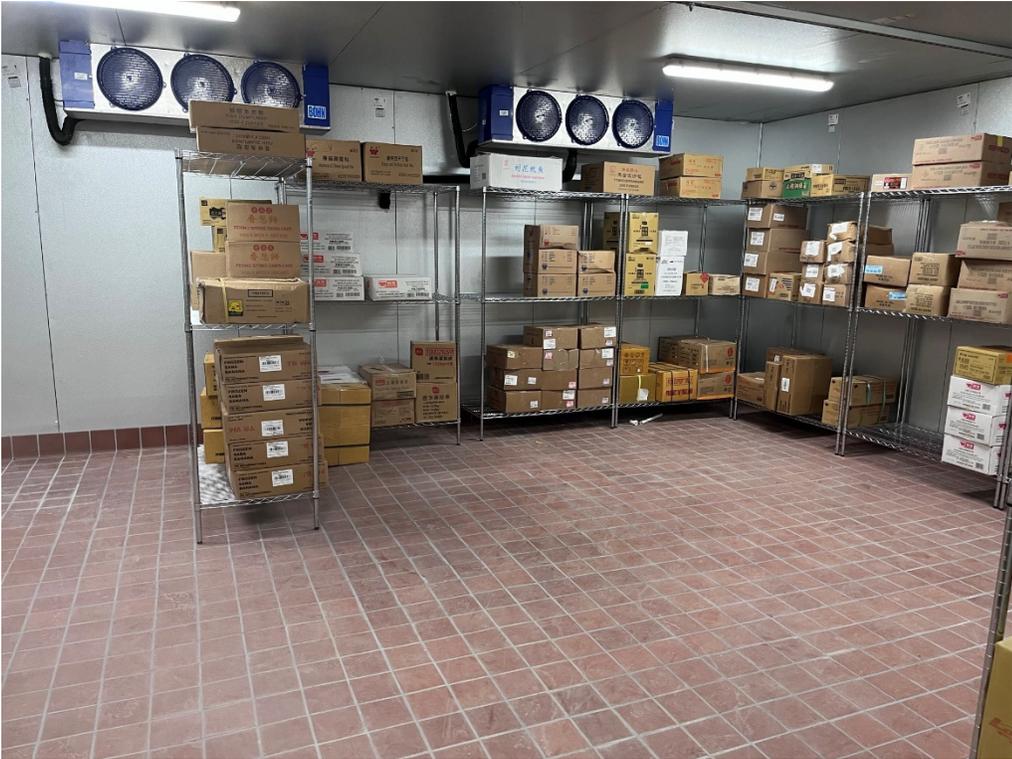
Figure 26 – Freezer Operational
