Thursday, January 5, 2023

Architect's Field Report

5465 Interstate 55 North Frontage Rd, Jackson, MS 39206

Midtown Jackson

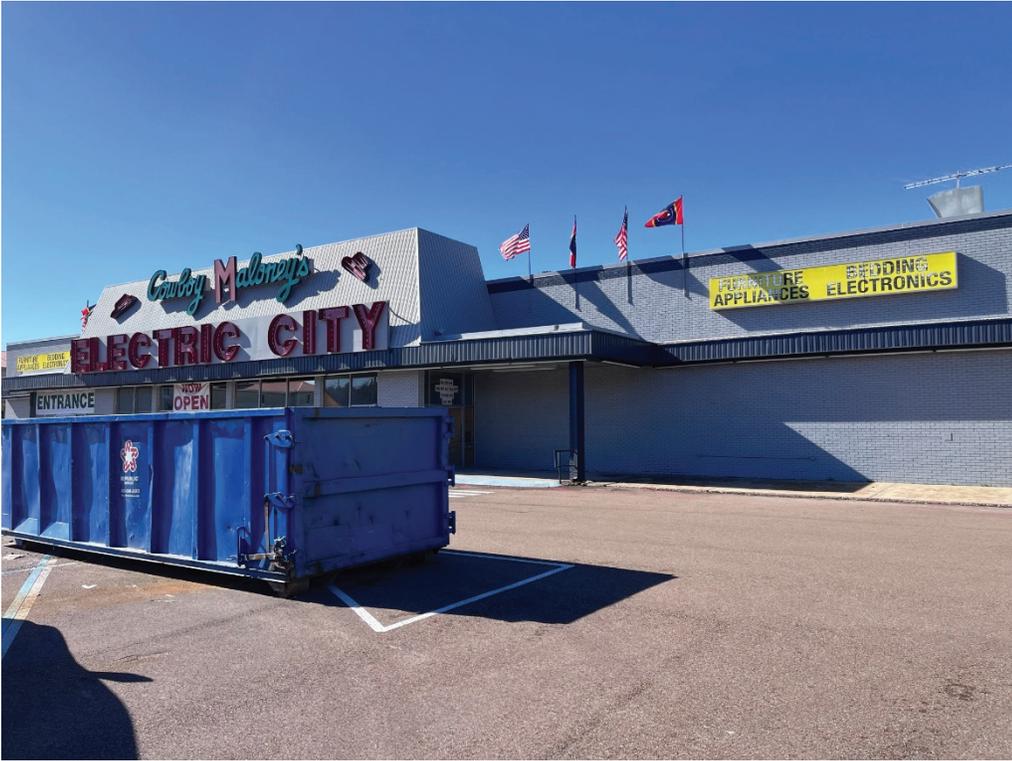
Figure 1 – Property Front

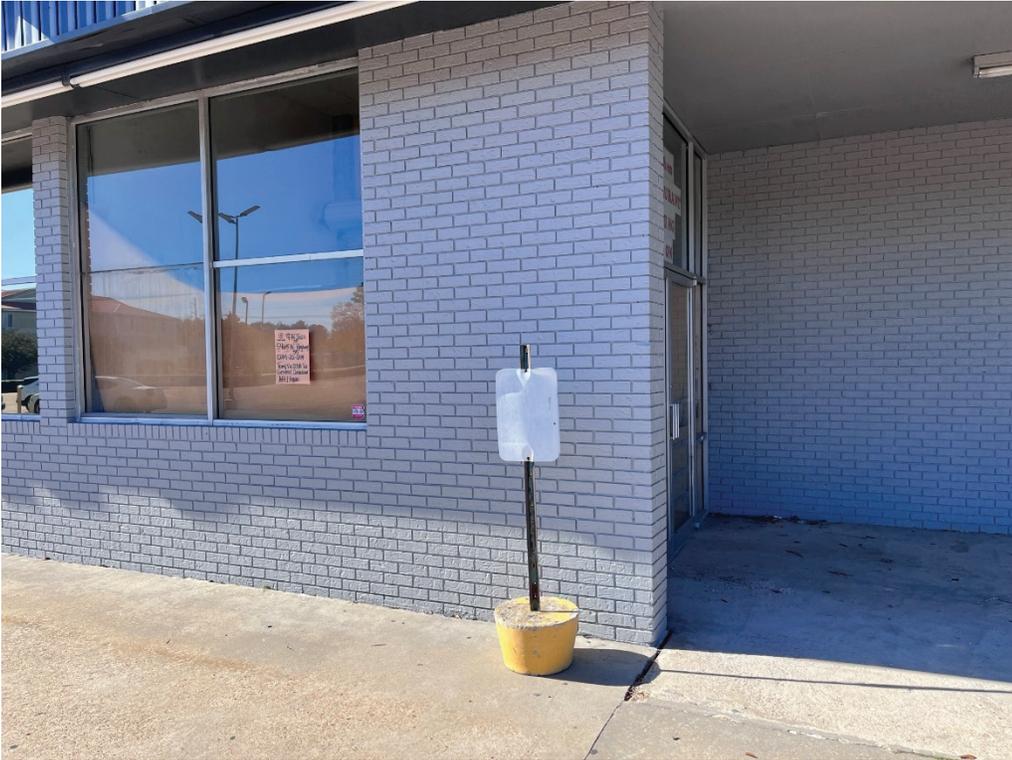
Figure 2 – Exterior Permit Location

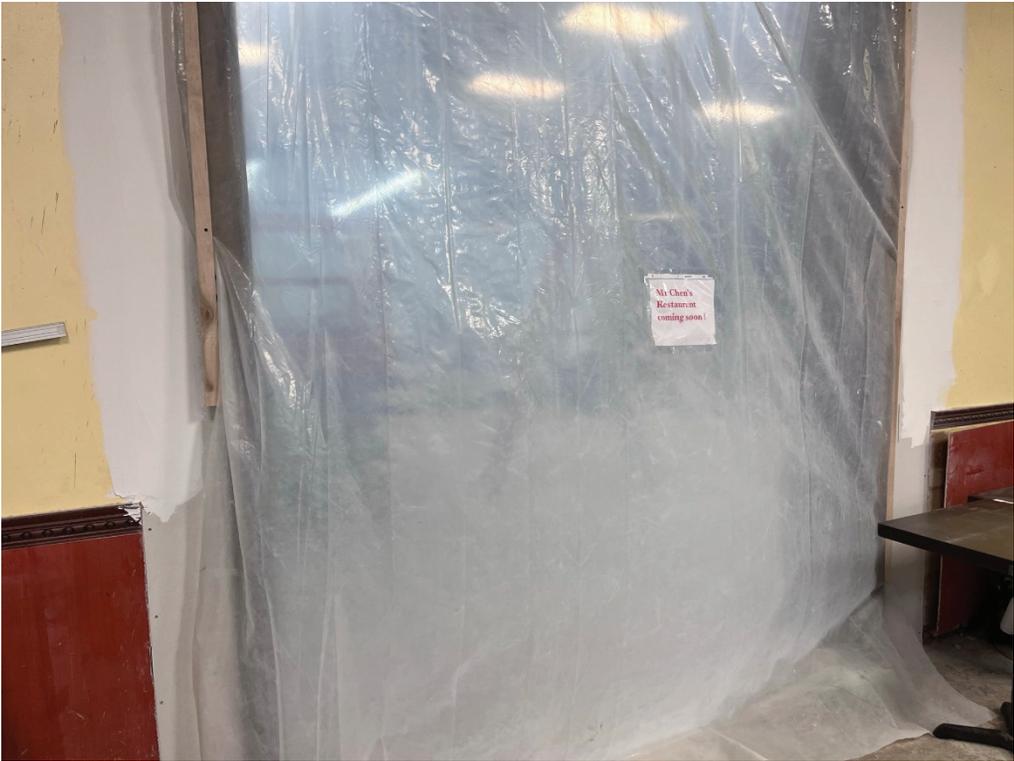
Figure 3 – Seal Improved at connection to operating grocery

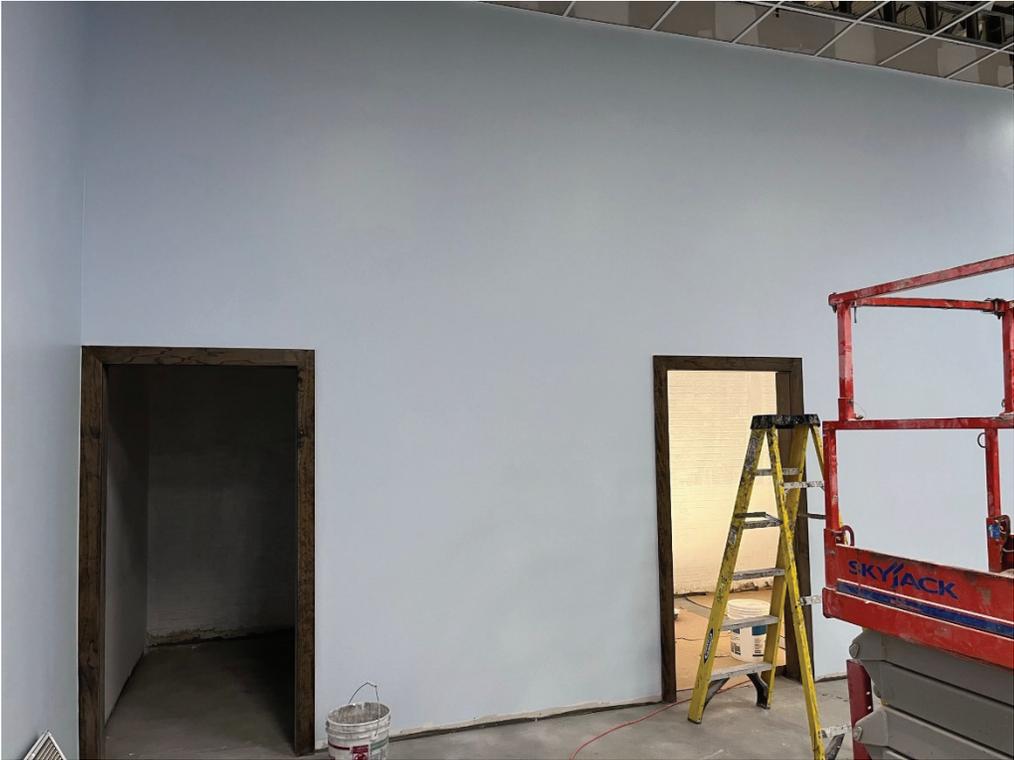
Figure 4 – Paint and Finishes are Ongoing

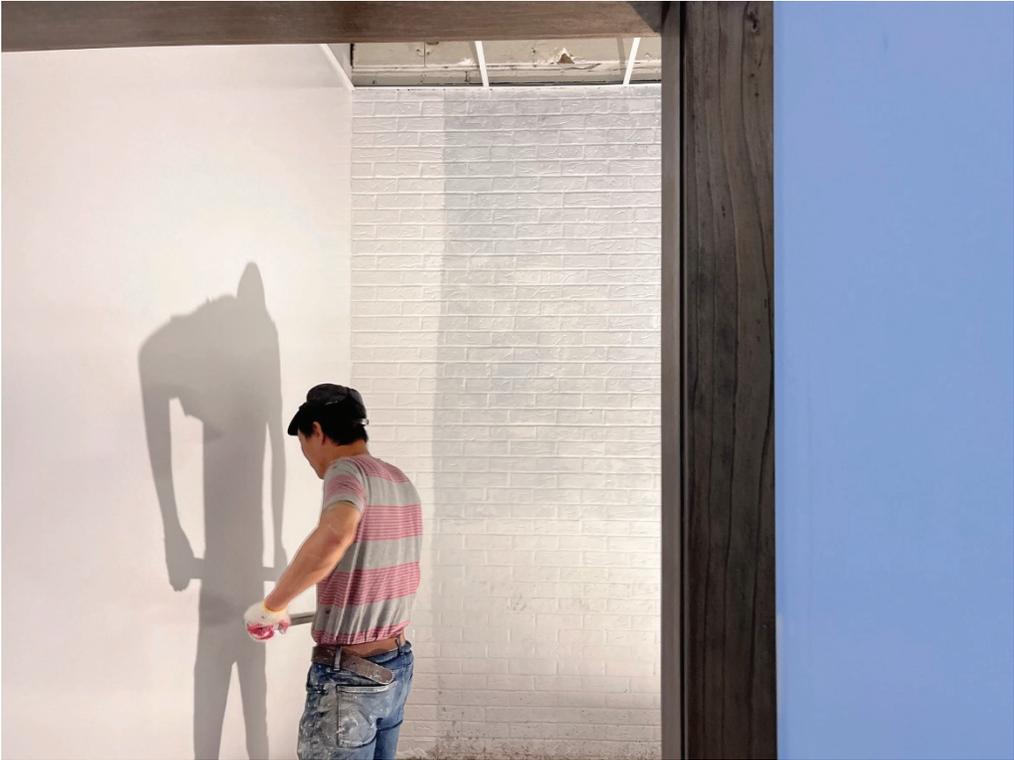
Figure 5 – Painting is Ongoing

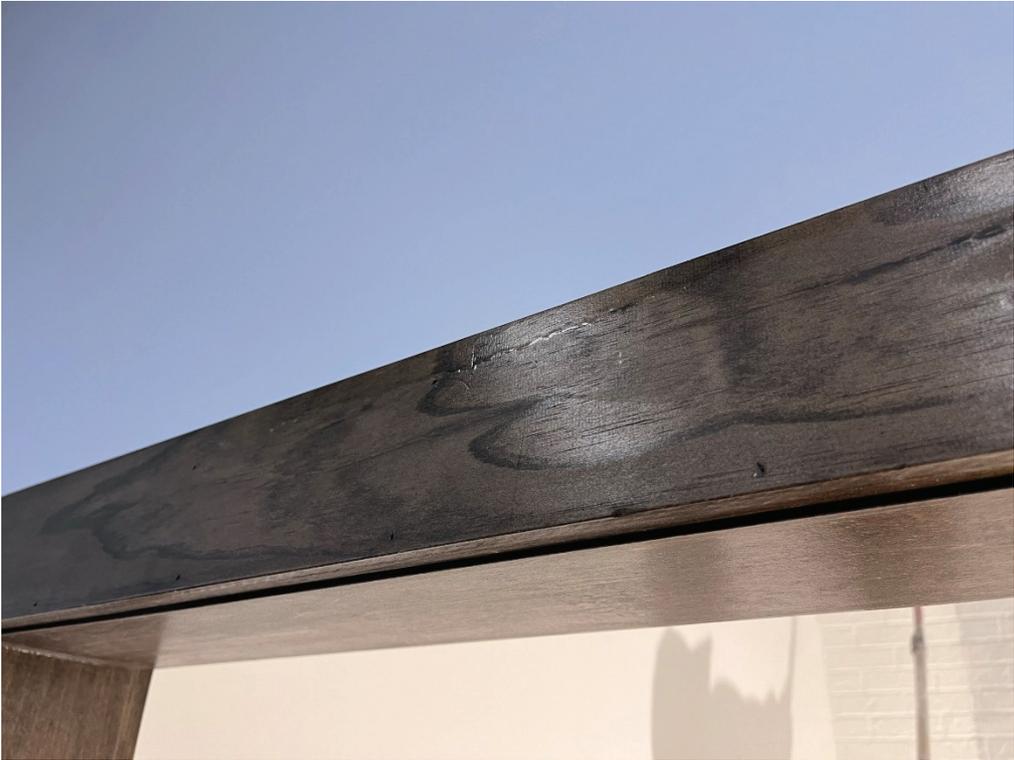
I arrived on the job site at 11:00 AM. I entered through the grocery; finish workers were inside installing paint and carpentry materials. Work appeared to be good except there were some drips noted in the gloss finish over stained wood. I Spoke to Fisher Yu (Mr. Chen's) about the drips and he said that the painter was already aware and planned to sand and top coat.

Figure 6 – Drips noted at Finishes

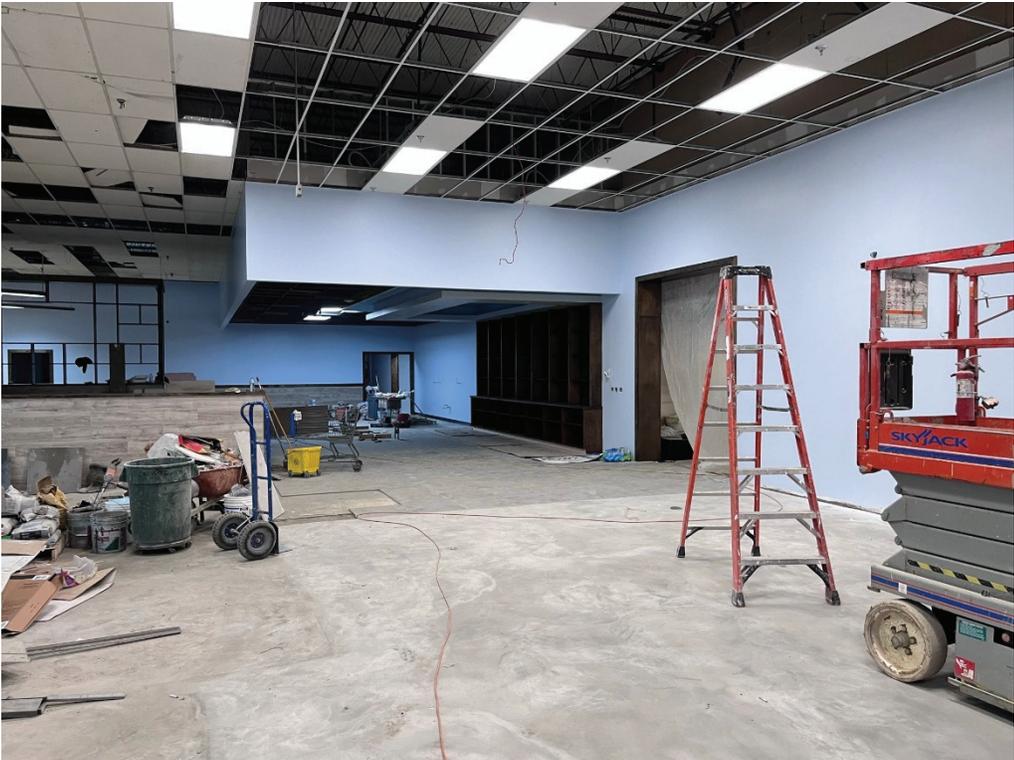
Figure 7 – Entry to Chen’s Dining; Levolor poured at floor as finish floor

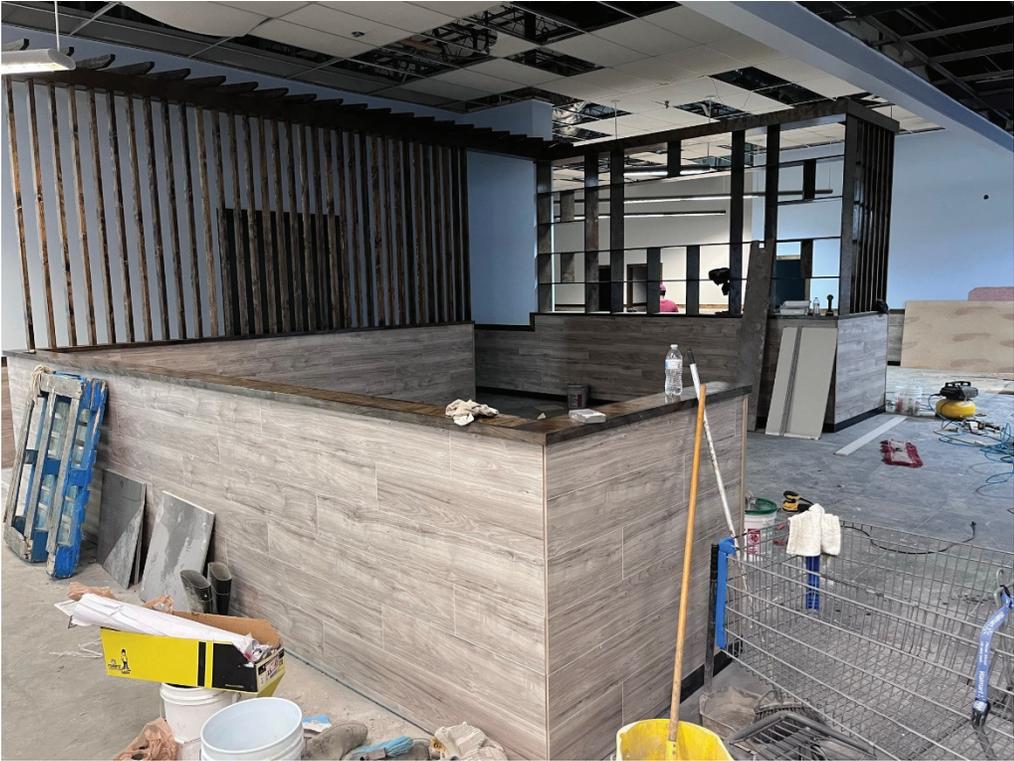
Figure 8 – Front Dining Area

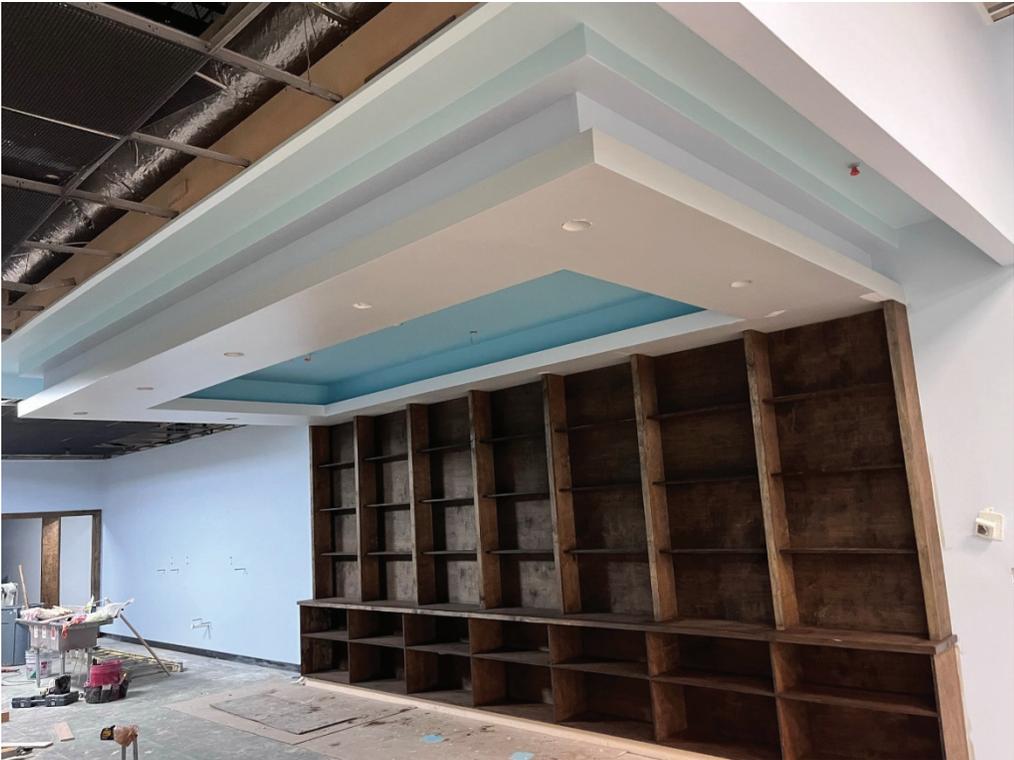
Figure 9 – Counter Dining Area

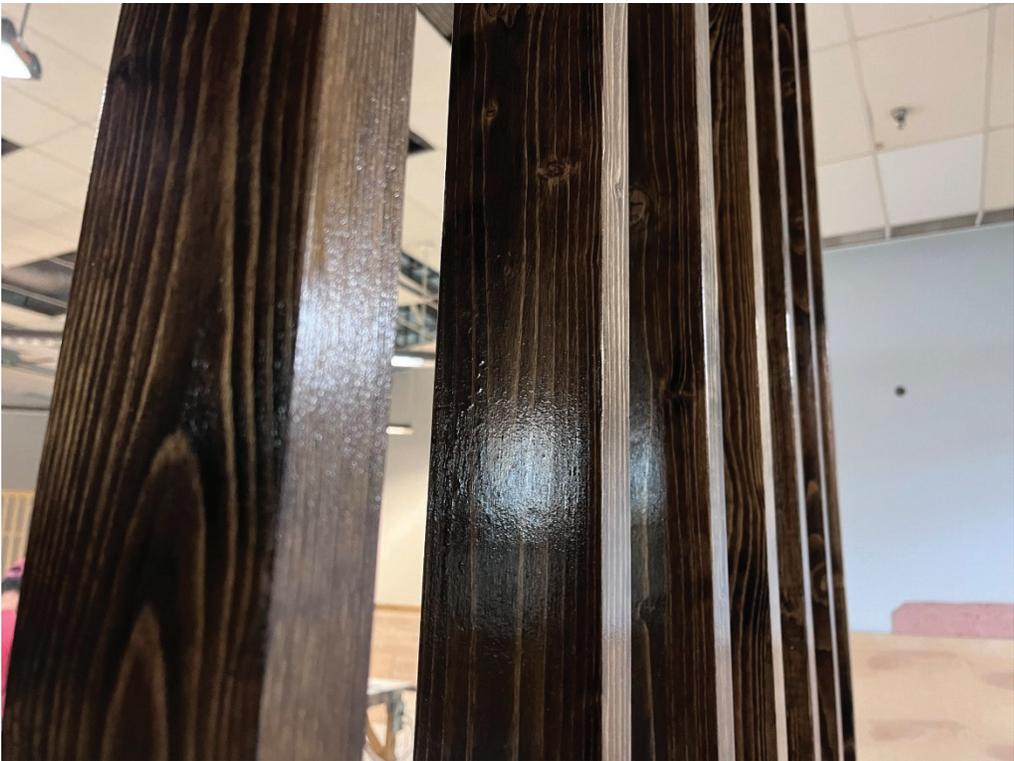
Figure 10 – Drips noted at finish

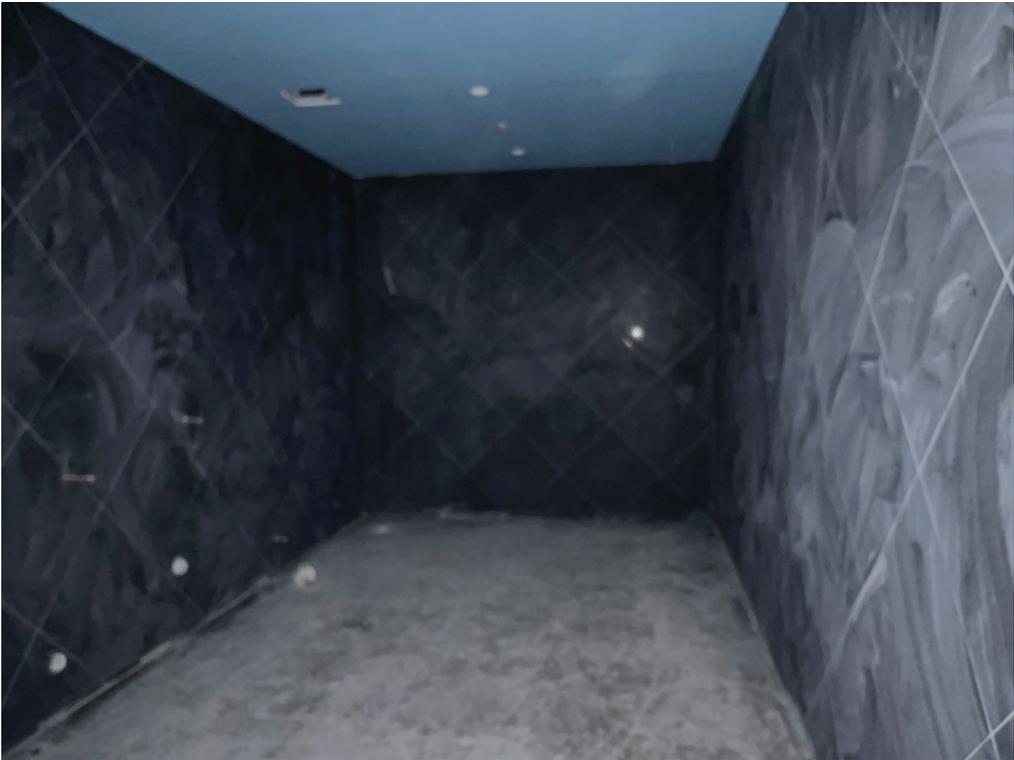
Private dining areas appeared to be complete other than cleaning. Toilet rooms have finishes installed but no fixtures.

Figure 11 – No Progress noted in Toilet Rooms

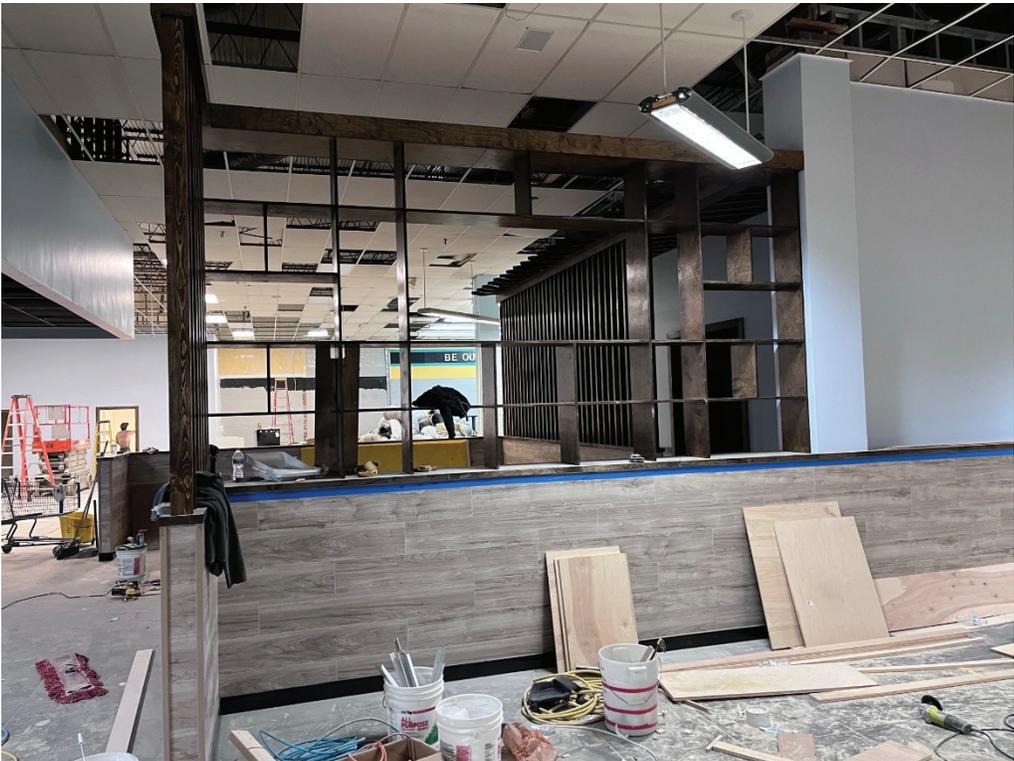
Figure 12 – Finish Installation Progress

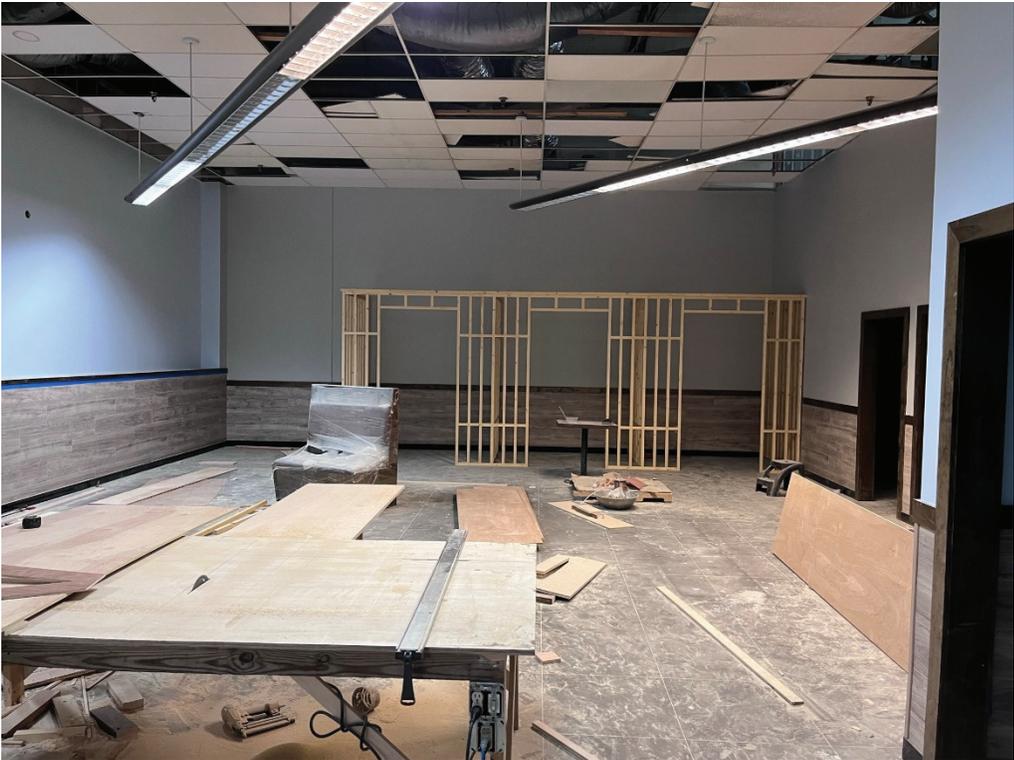
Figure 13 – Booth Enclosure Construction

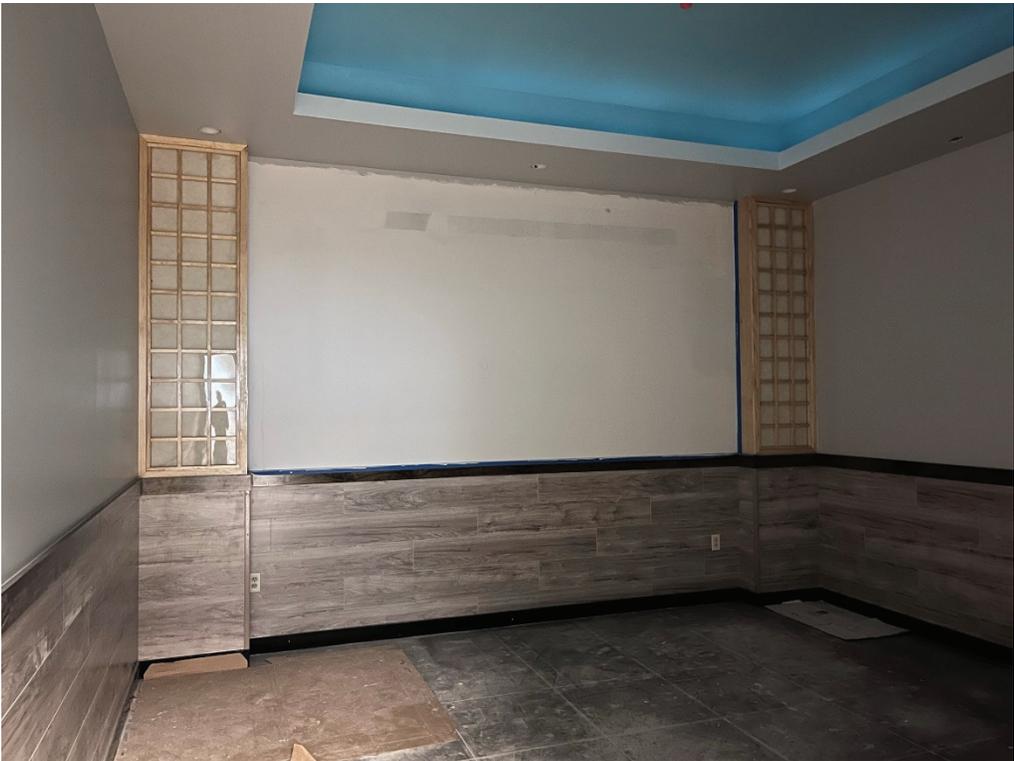
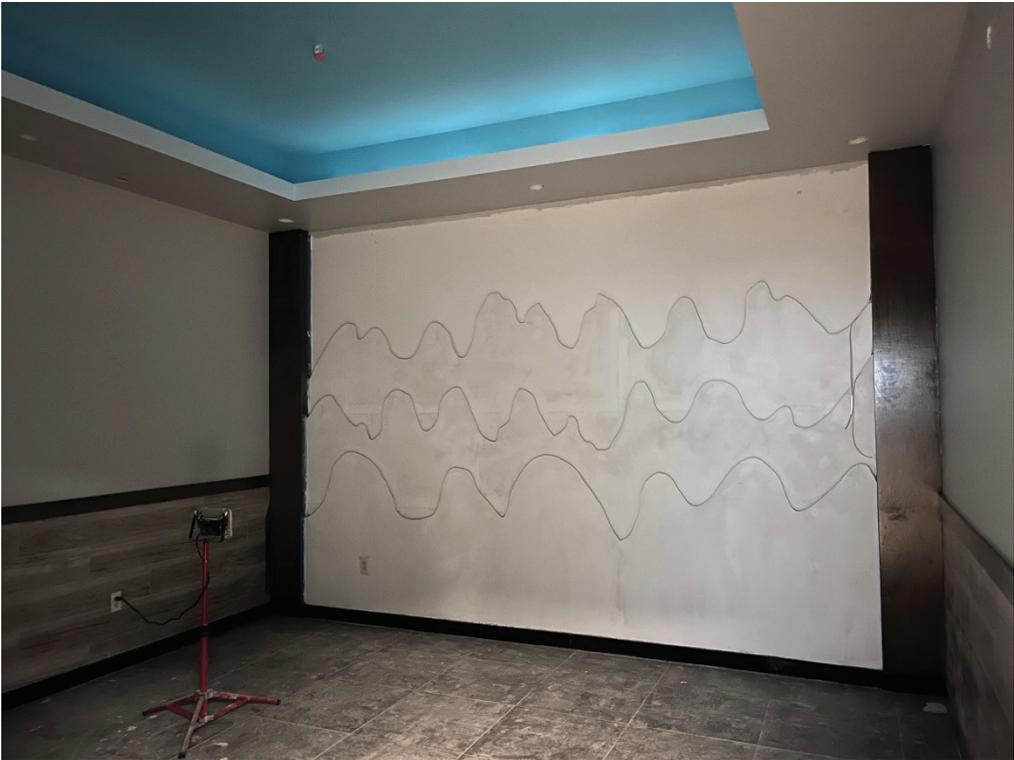
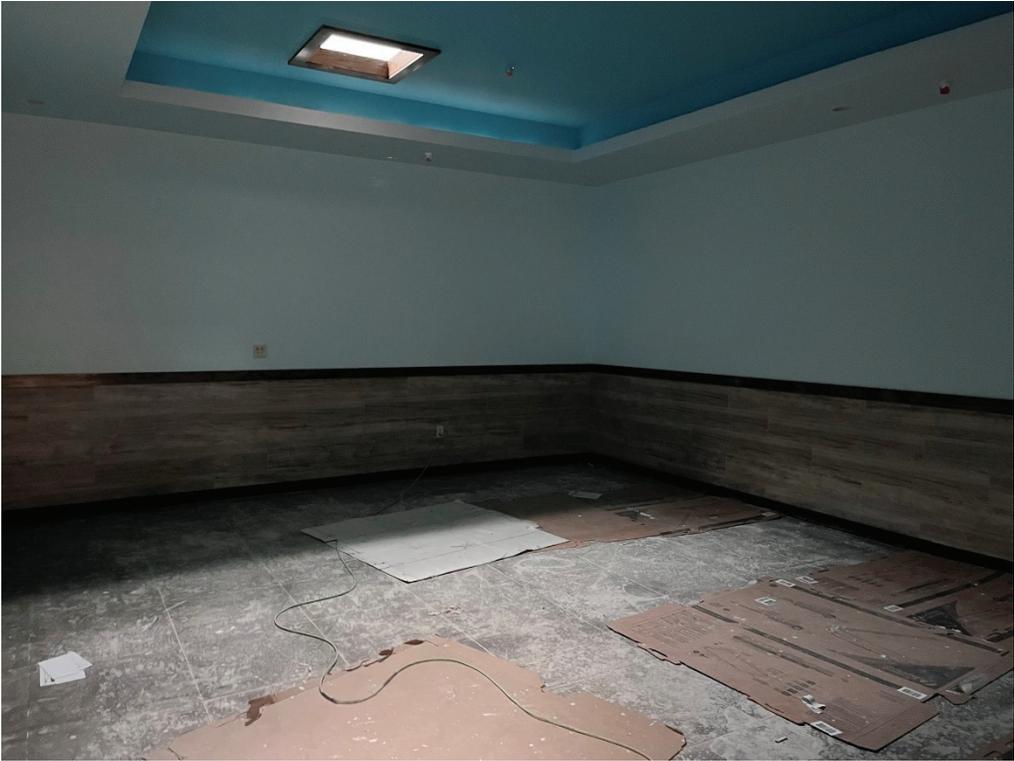
Figure 14 – Private Dining Rooms

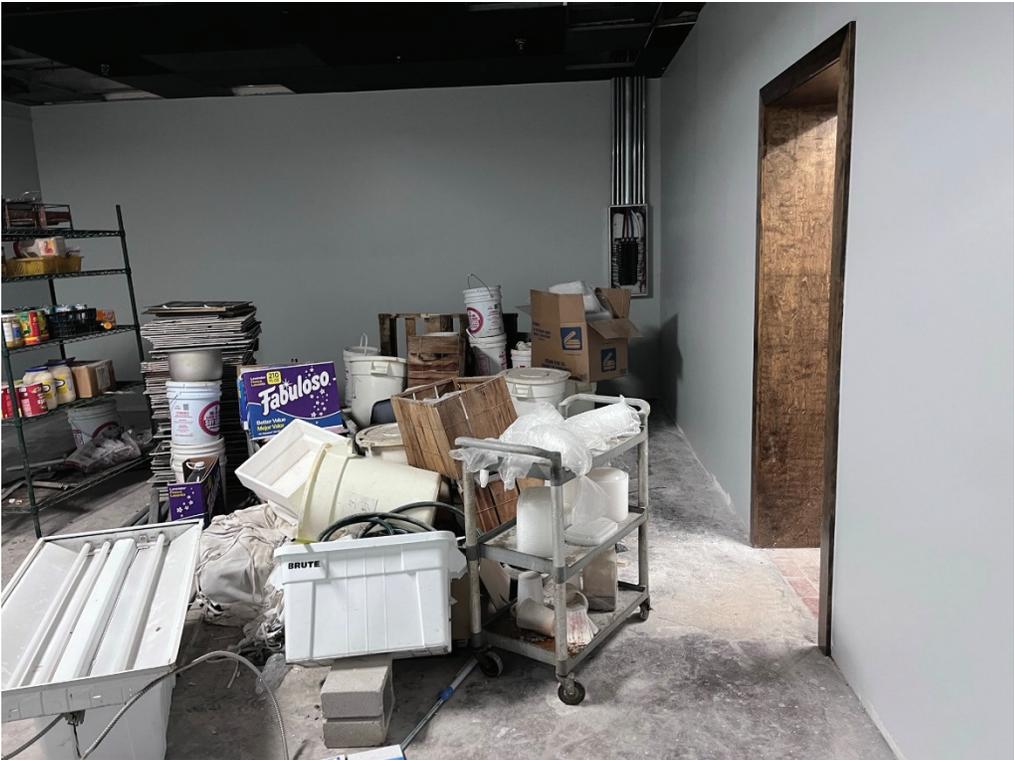
Figure 17 – Storage at rear of newly remodeled space

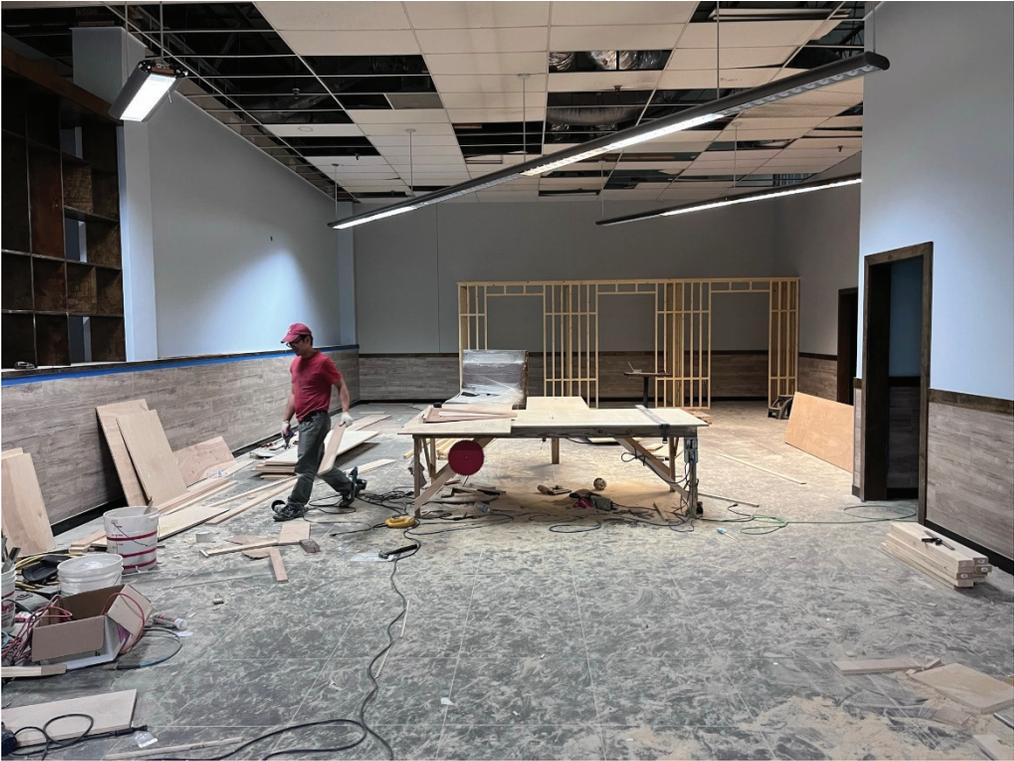
Figure 18 – Finish Carpentry is Ongoing

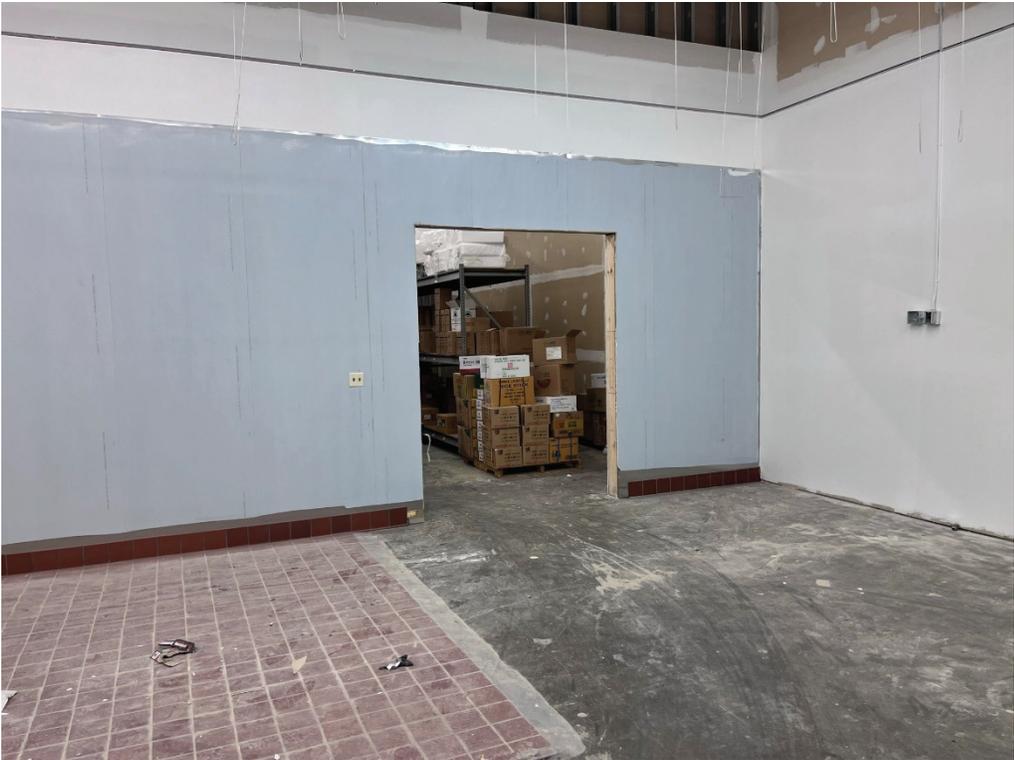
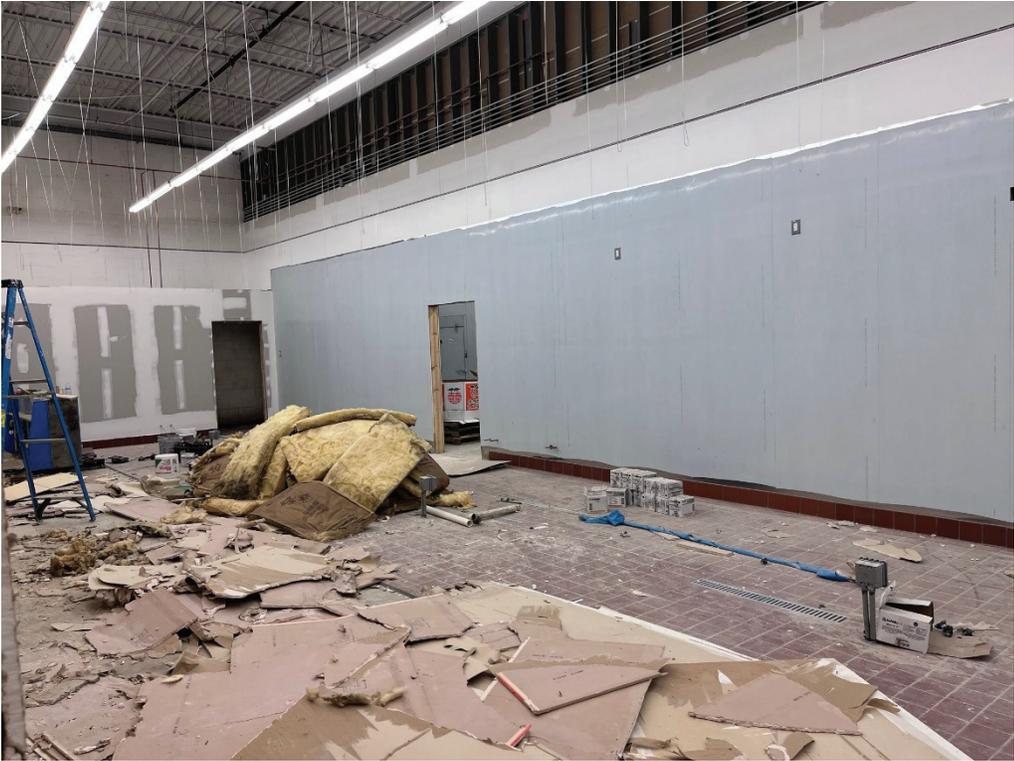
At the rear warehouse area, an egress door has been installed to the exit hall. Some demo has been performed in this area on gypsum board on the wall connecting the warehouse to the main grocery. No other work was noted.

Figure 19 – Limited Progress noted in warehouse expansion

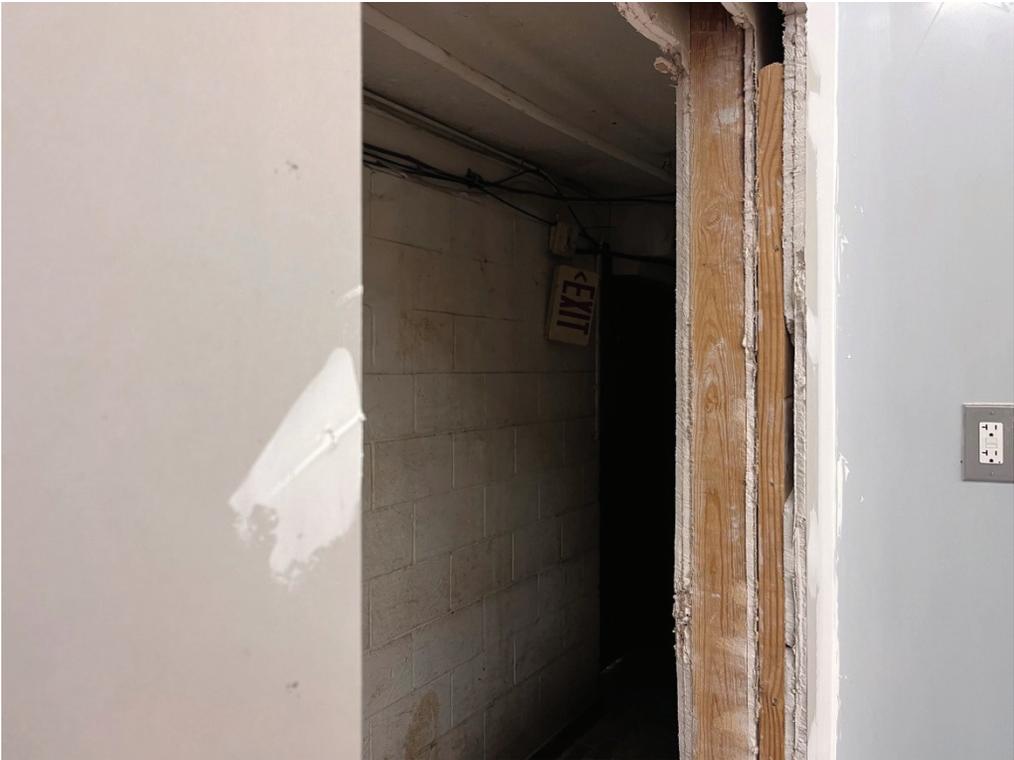
Figure 21 – Opening cut for egress to exterior

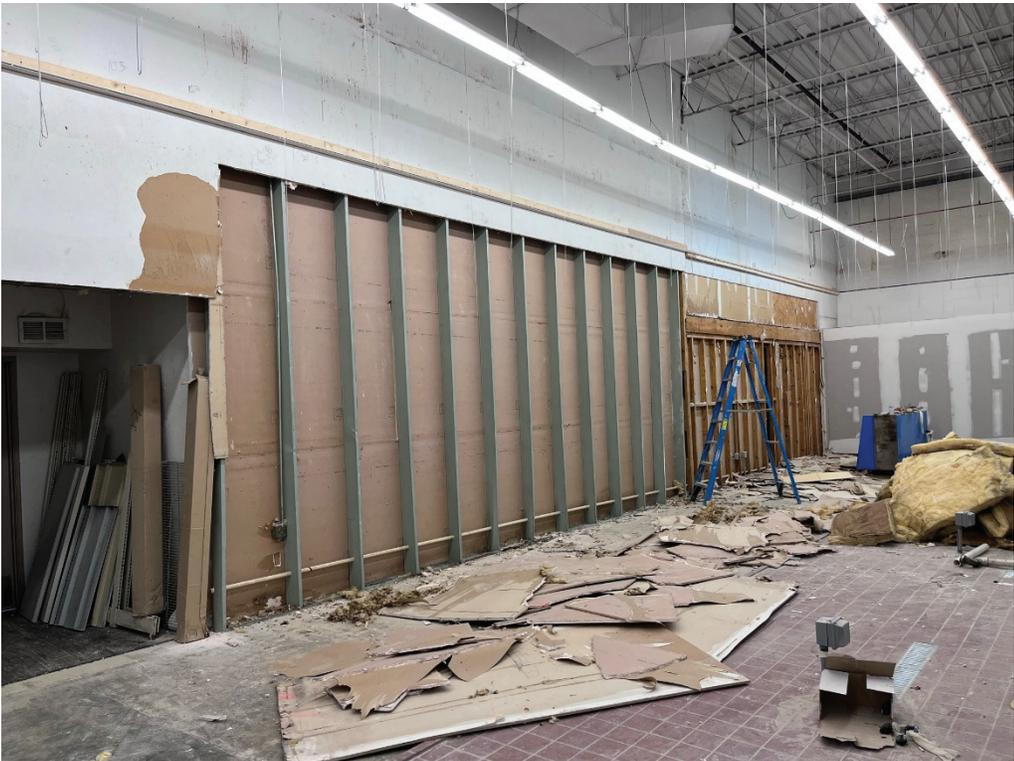
Figure 22 – Gypsum Demo at warehouse expansion
